Eastern Bays and Glendowie Watercourse Assessment Report

Morphum Environmental Ltd, April 2020

Watercourse Assessment Report

Morphum Environmental Ltd.

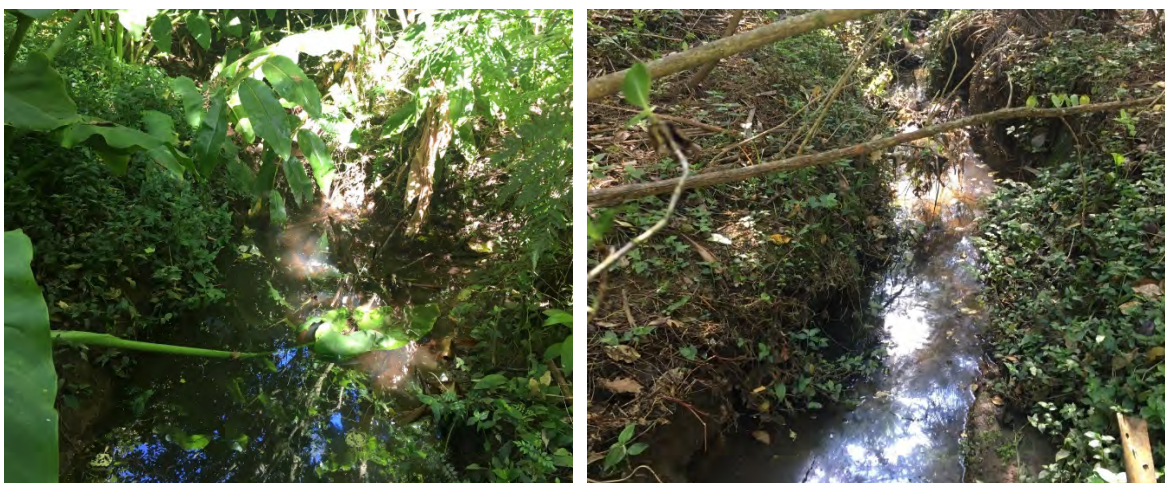
Erosion scarring on lower banks, noxious weed groundcover along KOH_MAIN_16.

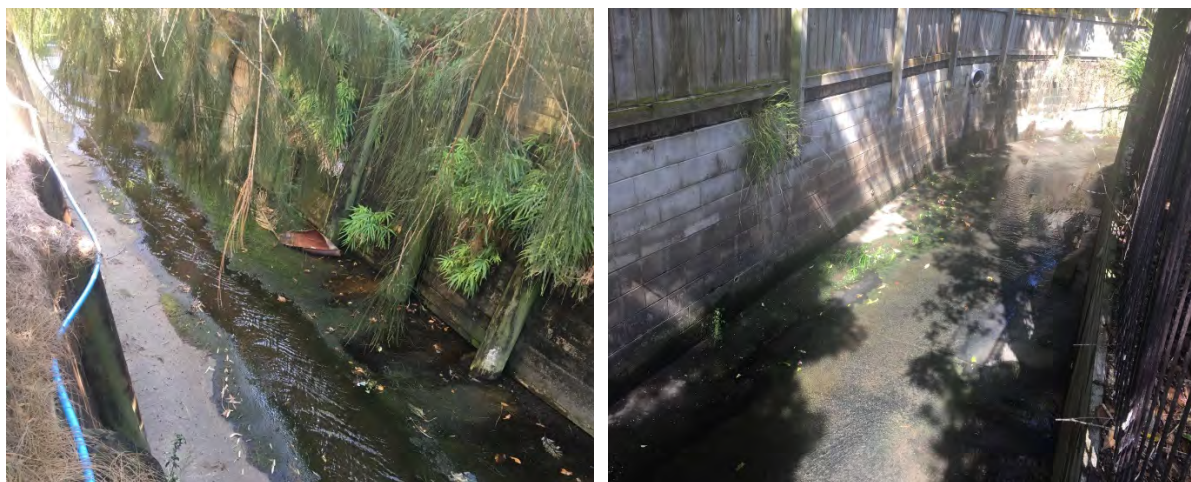
Figure 11: Typical examples of reaches in Management Zone 3. Concrete lined channels with timber bank lining on the upper reaches of the Glendowie Stream (GLE_TRIB4_9 left, GLE_TRIB4_5 right).

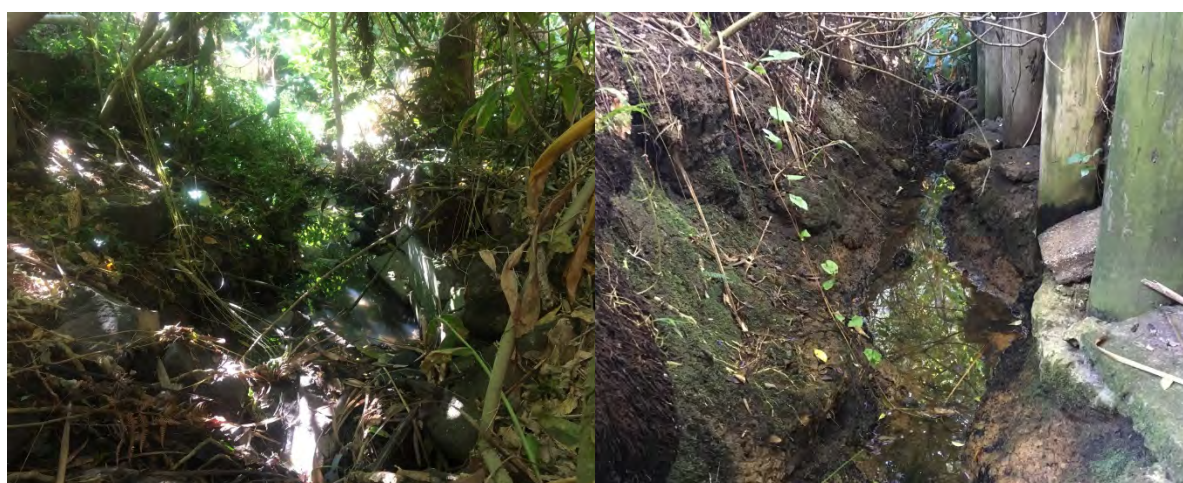
Modified reach along KOH_TRIB3a_6.

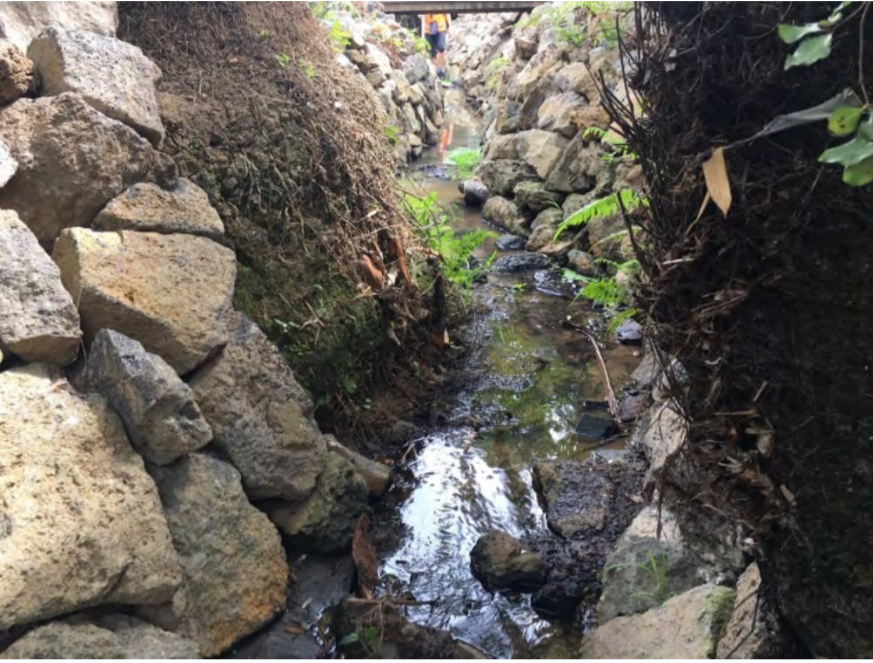
A reach of Mission Bay Stream through residential properties with riprap as bank lining (MIS_TRIB4_3).

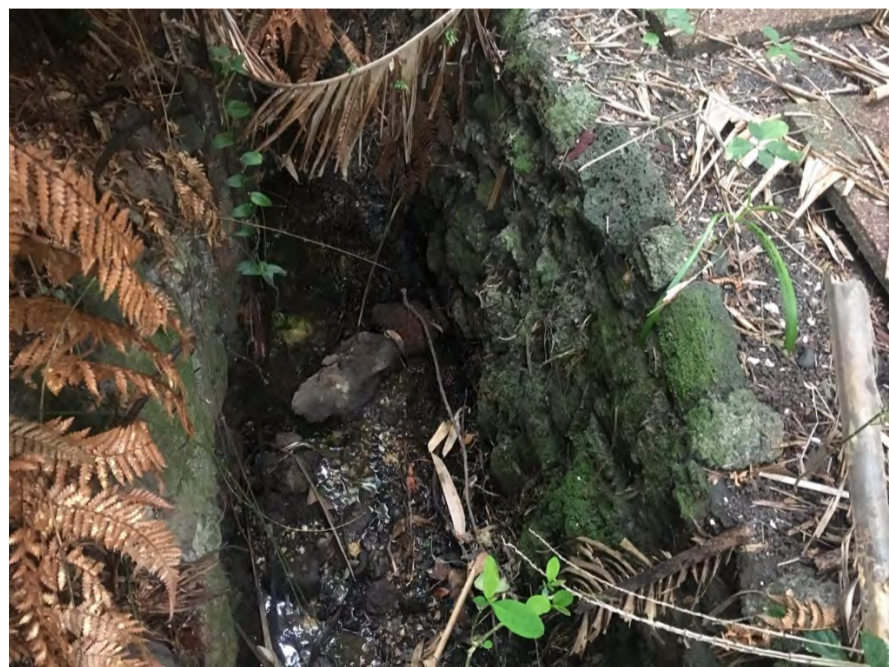
Approximately 70 m of Karaka Bay Stream is lined with concrete and rip rap (KAR_MAIN_1).

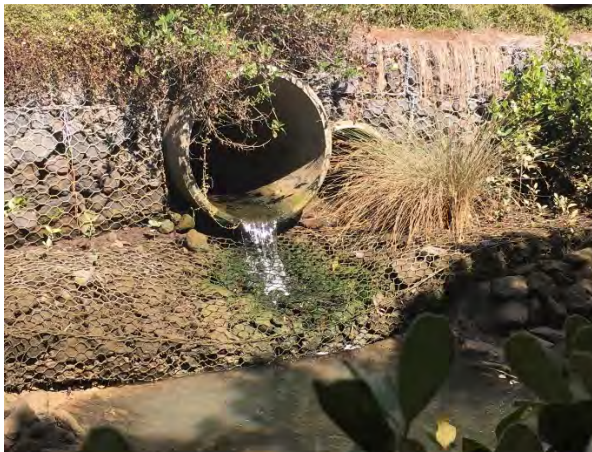
An Auckland Council owned asset (2000473115) is a complete barrier to fish passage. This pipe discharges into the Glendowie Stream Mouth and coastal marine area has a 1m drop height across reno mattress into the channel bed.

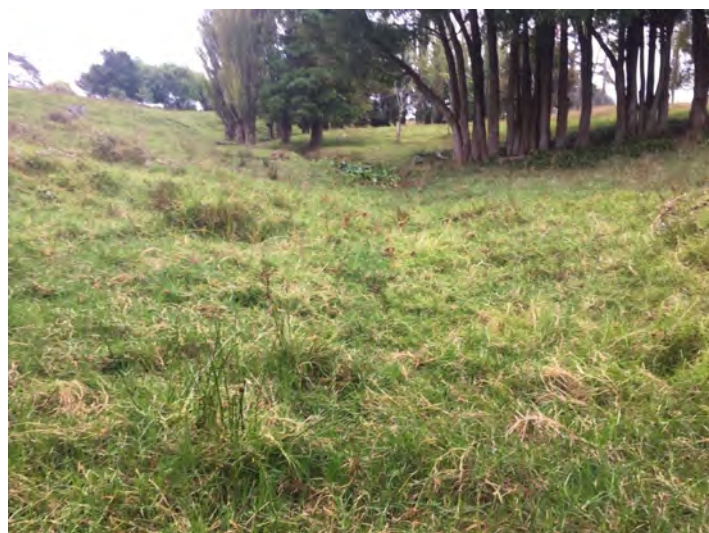
Figure 26: Natural riverine wetland in Churchill Park (Tributary ID: GEE_MAIN_FORK2a_1) caused by stock damage and pugging.

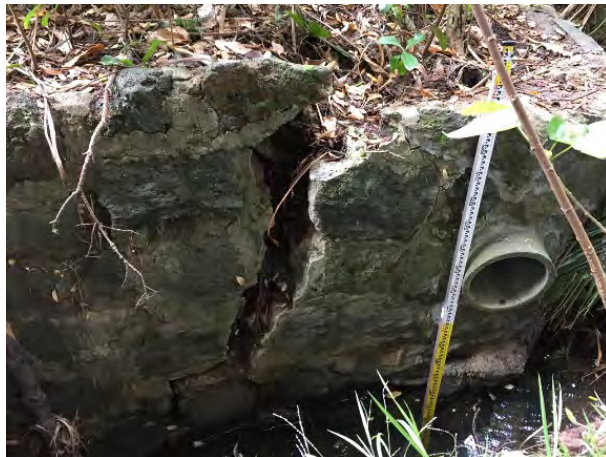
Detached headwall in Dingle Dell Reserve (2000649833).

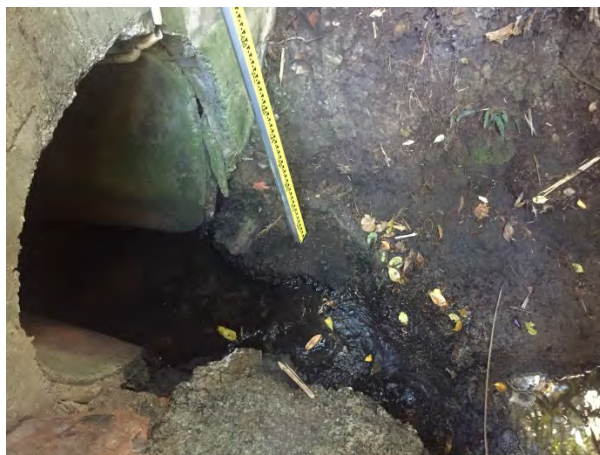
Informal cast in-situ concrete headwall that is cracked and erosion of the bare earth banks on both banks at 53 Clarendon Rd (2000677856).

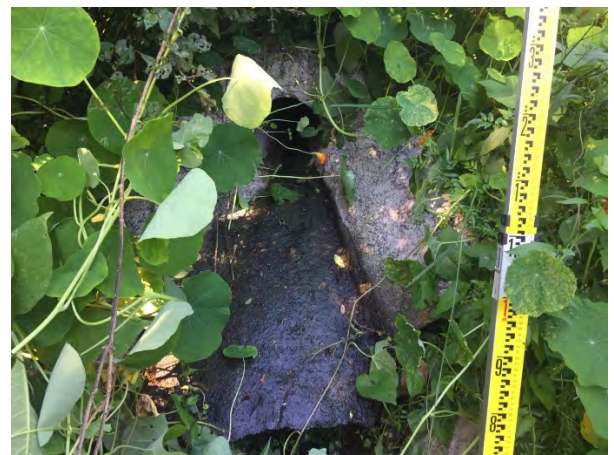
Informal concrete outlet at 23 Tarawera Terrace is undercut and may fall into stream channel (2000780248).

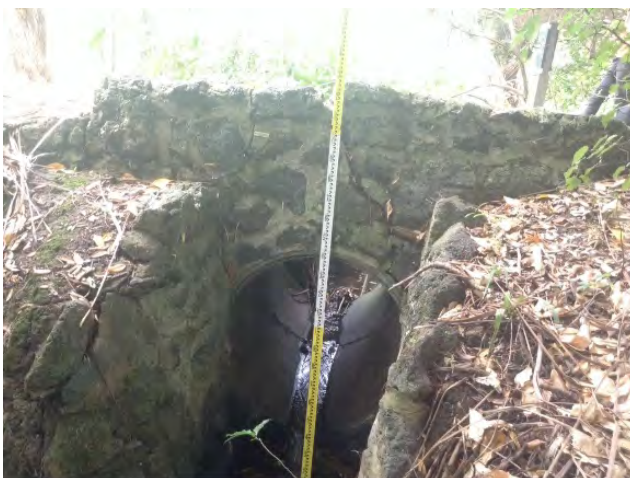
Cracked culvert bridge in Dingle Dell Reserve (EBS_004, EBS_005, EBSP_003).

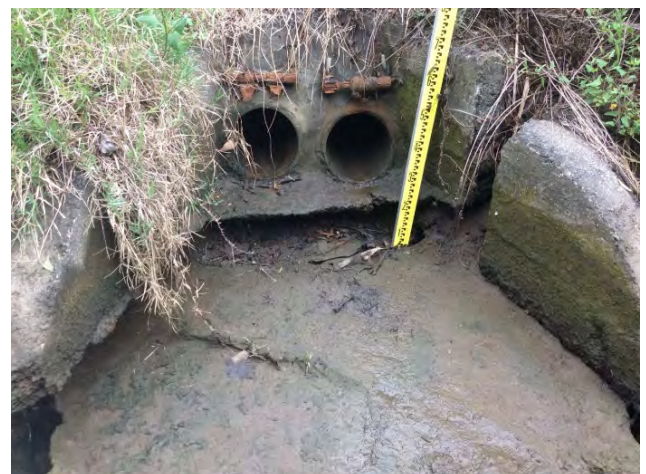
Outlet with detached wingwall, apron and snapped off tide gates (2000799090).

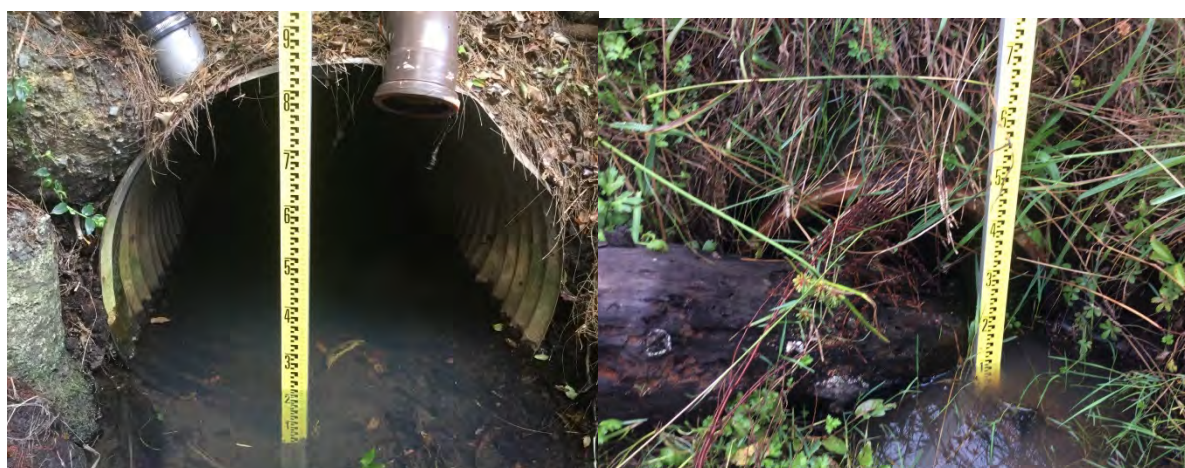
AC owned corrugated iron culvert on 23 Yattendon Road (2000176700) on private land needs lining with concrete or full replacement. Culvert in Churchill Park that is blocked and in poor condition (GLDSP_003).

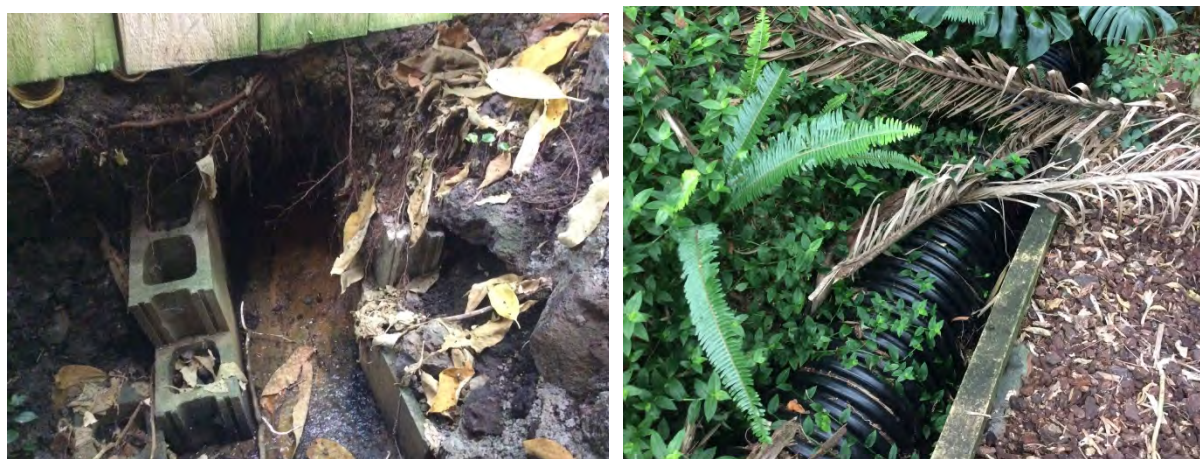
Cinder block culvert GLDSP_011.

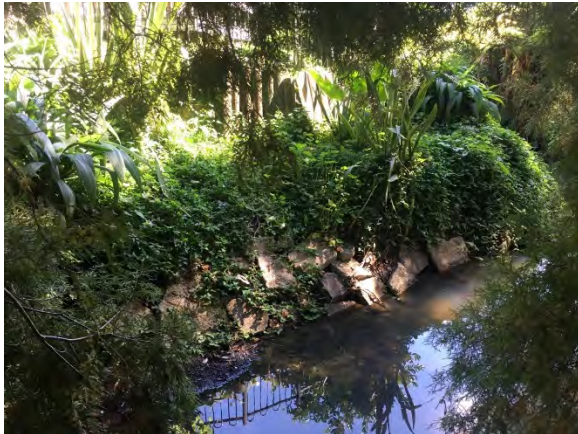
Bank lining in Churchill Park (AC land) (UNK_004) made up of poorly placed concrete blocks and gabion baskets.

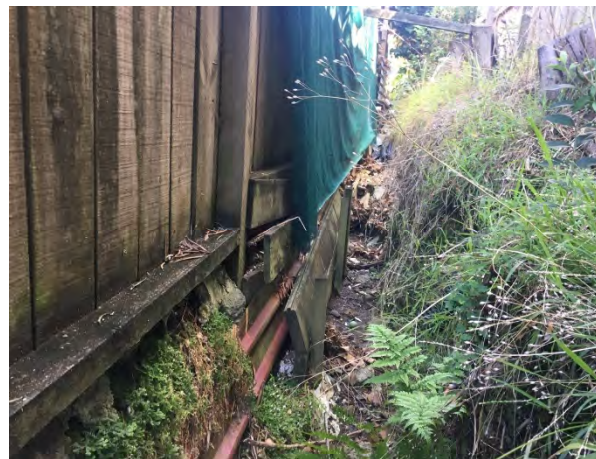
Haphazard bank lining encroaching on a nearby shed (STH_TRIB4_4) (UNK_056).

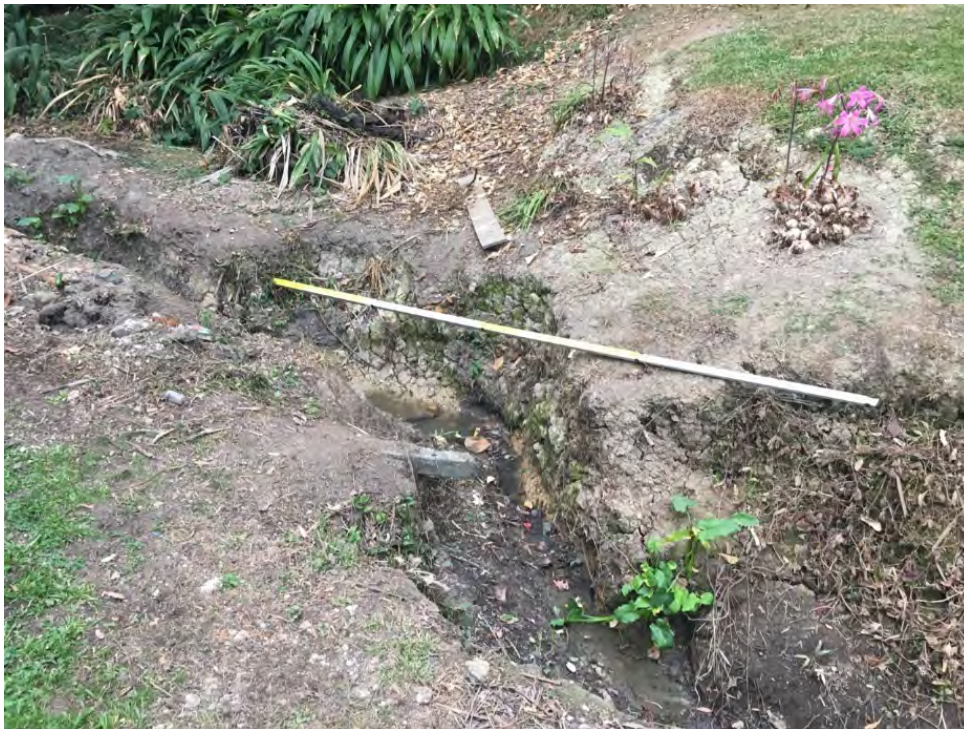
Figure 31: Erosion hotspot exacerbated on private property by poor riparian planting on MIS_MAIN_6.

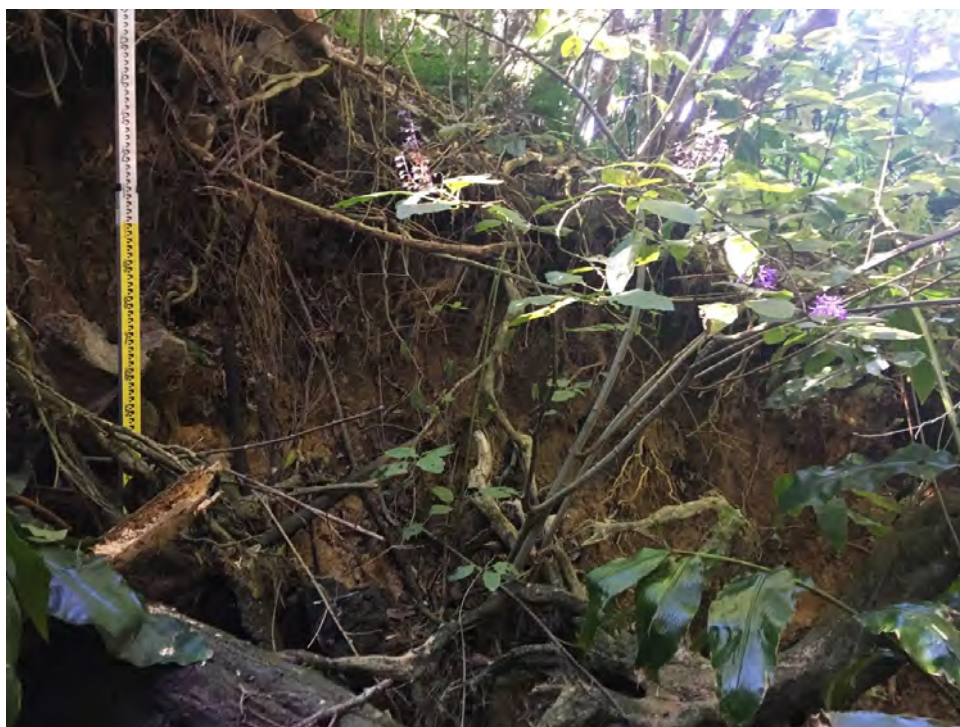
Figure 32. The erosion hotspot at KOH_TRIB7a_1 is associated with the stormwater outlet (Asset ID: 2000130324) shown on the top left-hand corner of the image.

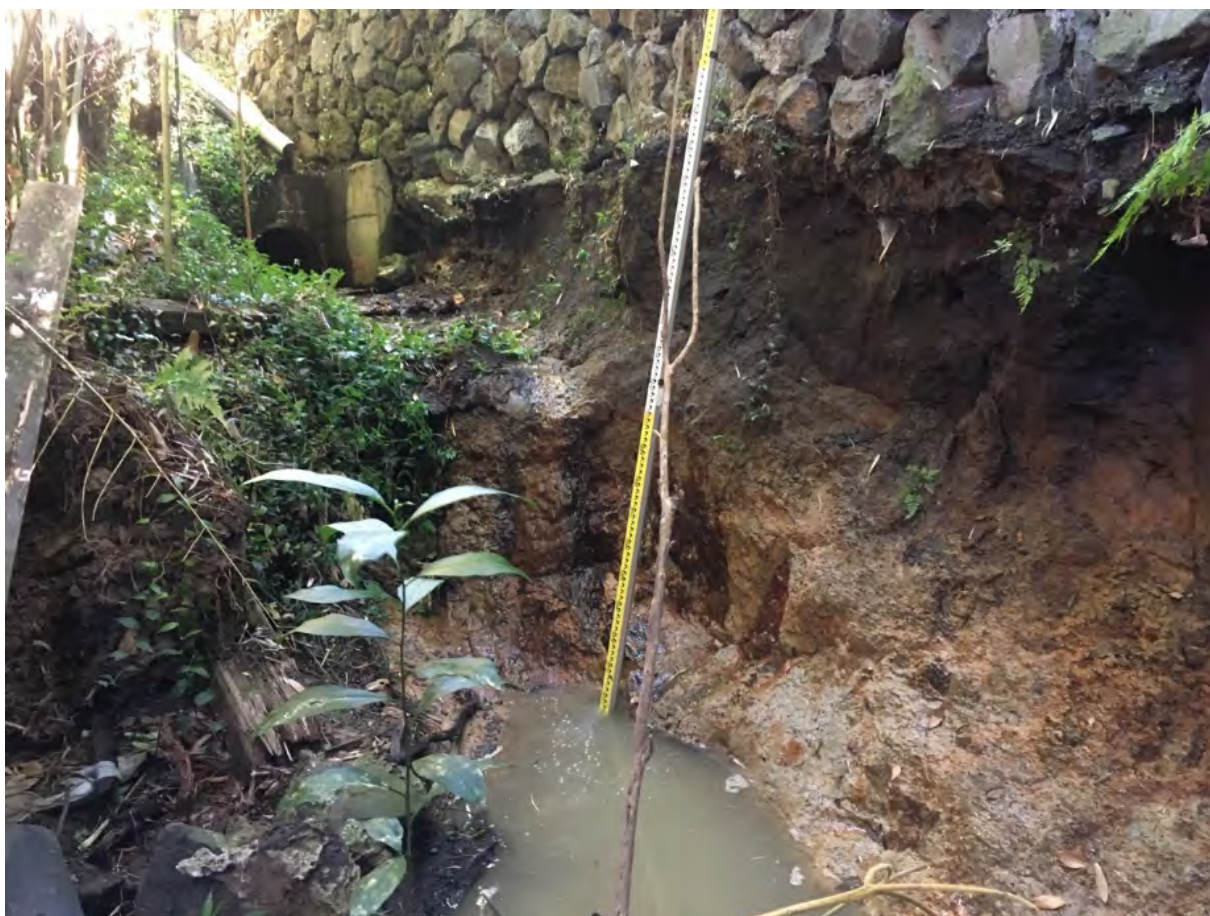
Figure 33: Erosion associated with under the retaining wall at 27 Geraldine Place along KOH_TRIB3a_5.

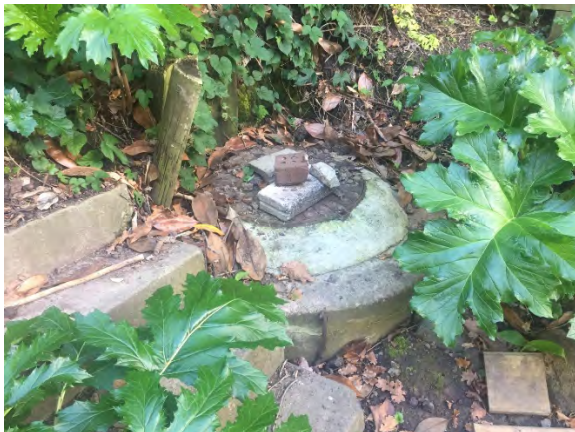
A possible stormwater manhole in the backyard of 4/36 Dingle Road (close to DIN_TRIB2_1) was reported to be popping open and causing local flooding in the back yard in rainfall events (Not in GIS).

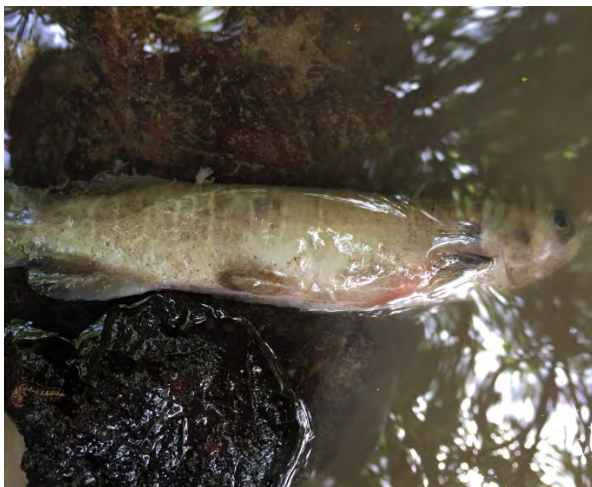
An upstream pool was discharging from 15 Fern Glen Road South into a road catchpit. In the Dingle Dell Reserve, approximately 300m downstream, two dead banded kokopu were found, potentially a result of the chlorine discharge (DIN_MAIN_3).

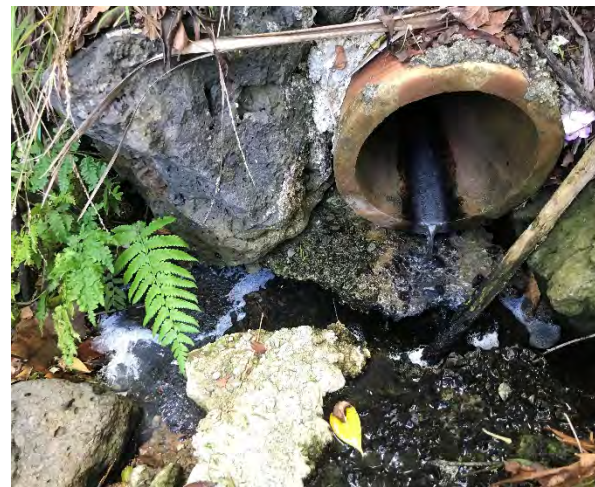
A white discharge was spotted coming out of an outlet (2000077826) into Mission Bay Stream (MIS_MAIN_1). At the property next door, a person was washing paint brushes into the stormwater drain and this is the likely source of the white milky discharge.

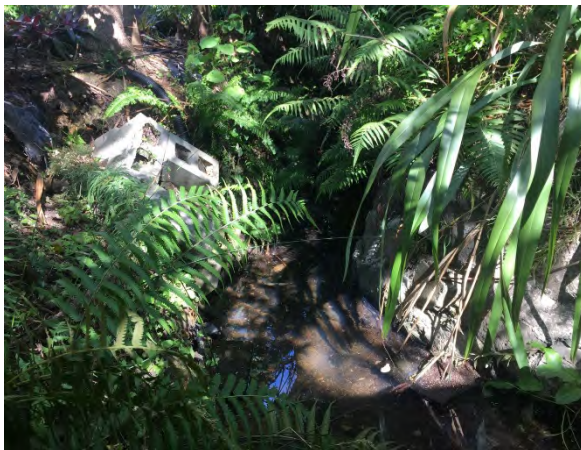
Mission Bay Stream EBG03 (MIS_TRIB4_1)
Reach on private land in variable condition with areas of bank erosion and other areas with good instream habitat.

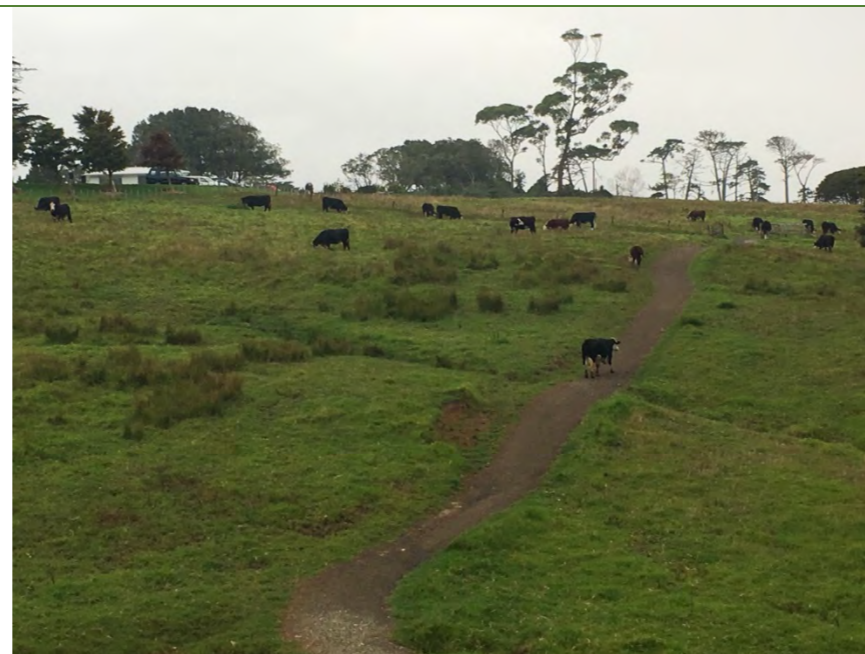
Stock have open access to the channels and there is sparse vegetation.

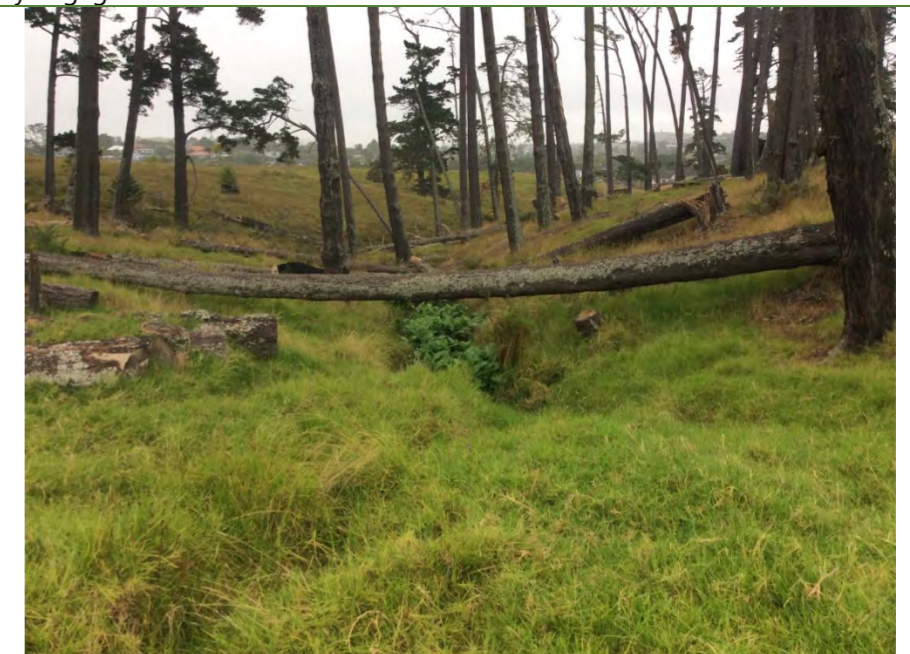
Modified channel with exotic cover of pine and no understory. Mass wasting of bank and incised channels.

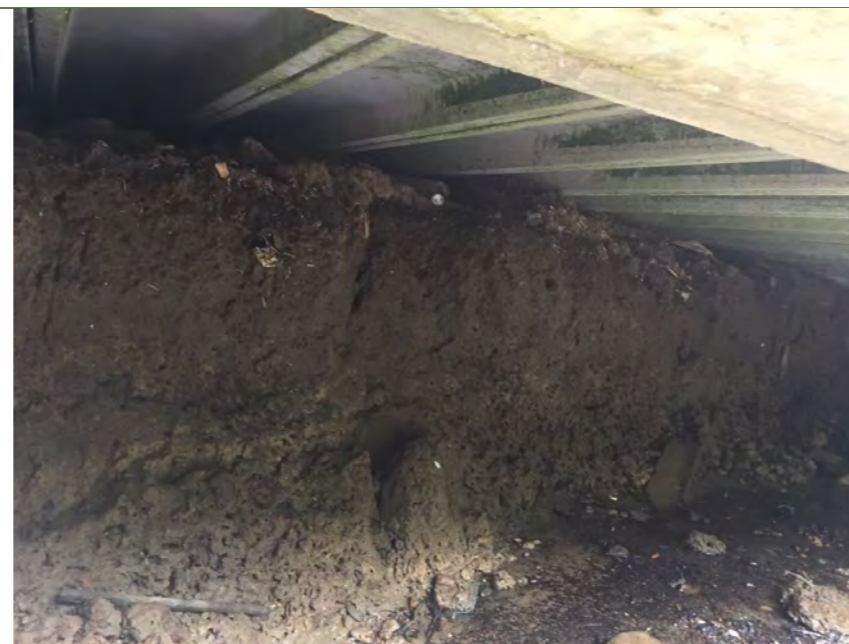
Undermining occurring the wall under the parking garage structure at 29 Tamaki Drive.

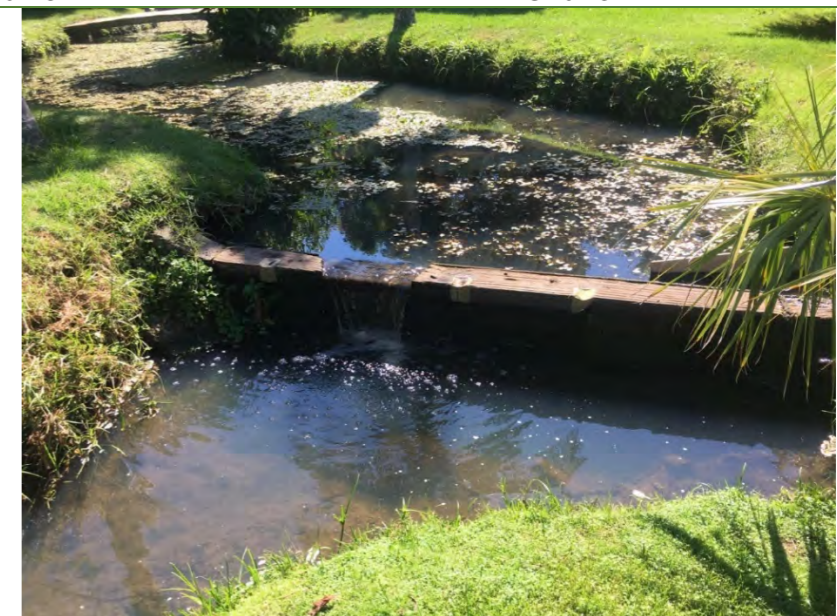
Weirs are complete fish passage barriers (GLE_MAIN_4).

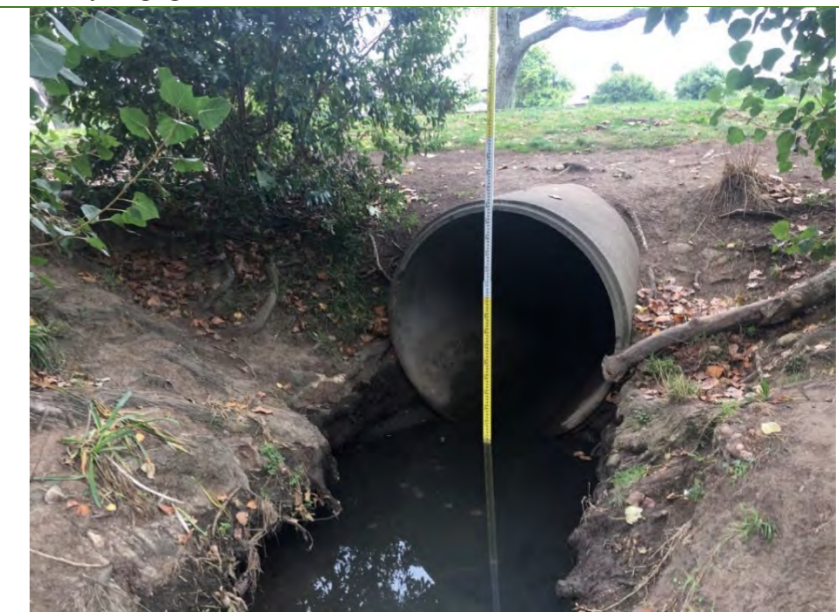
Asset ID 2000229311 with an unconstrained drop height of 1.6m close to the walking path.
