Eastern Bays and Glendowie Watercourse Assessment Report

Morphum Environmental Ltd, April 2020

Watercourse Assessment Report

Morphum Environmental Ltd.

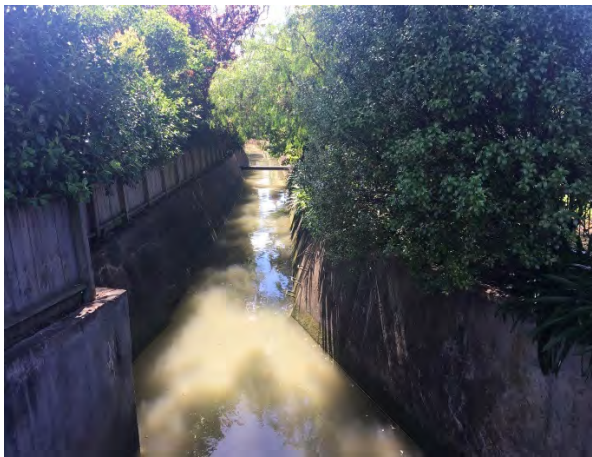
The coastal reaches located along KOH_MAIN 1 to KOH_MAIN_4, Mission Bay sub-catchment stream mouth are concrete lined with narrow riparian margins.

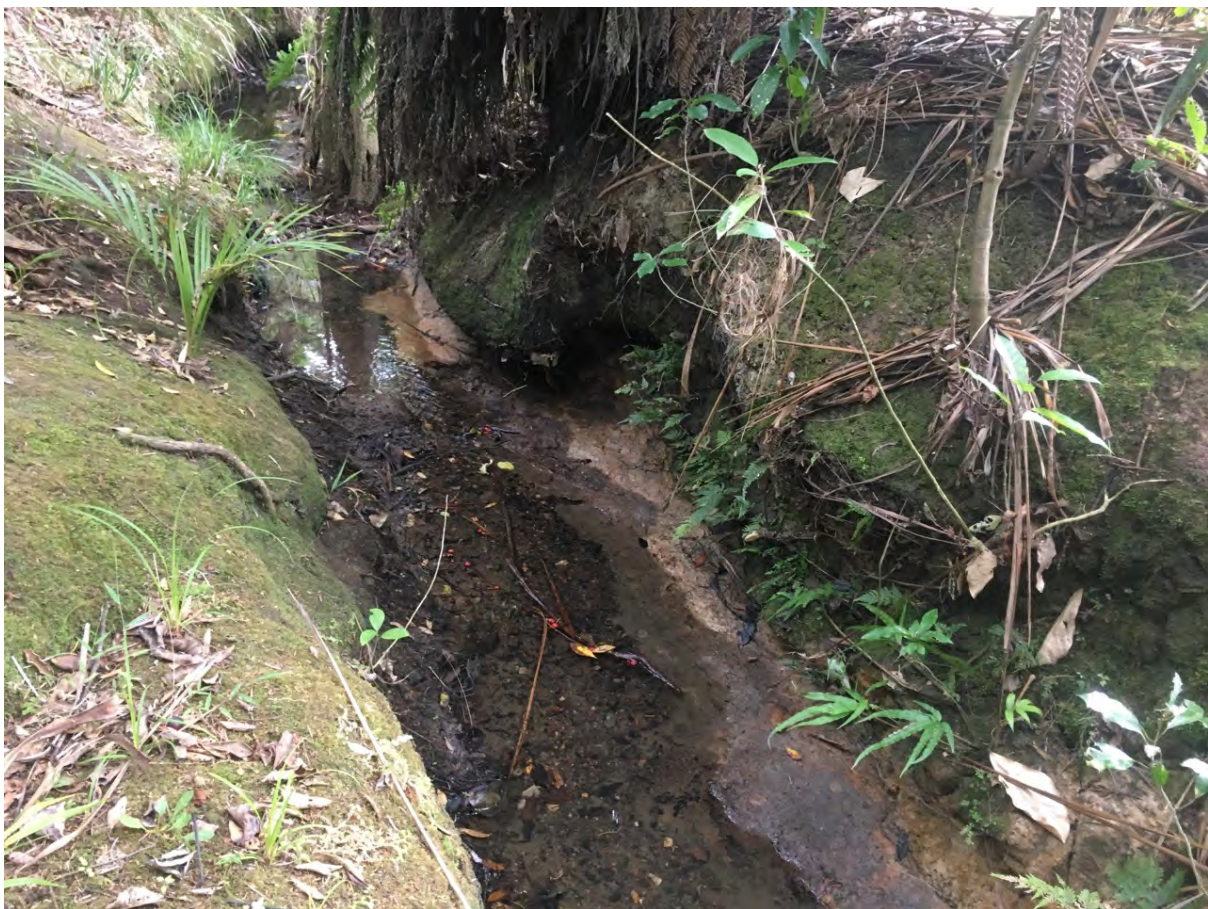
Figure 15: Reach in Dingle Dell Reserve with gravel beds potentially suitable for fish spawning (DIN_MAIN_3).

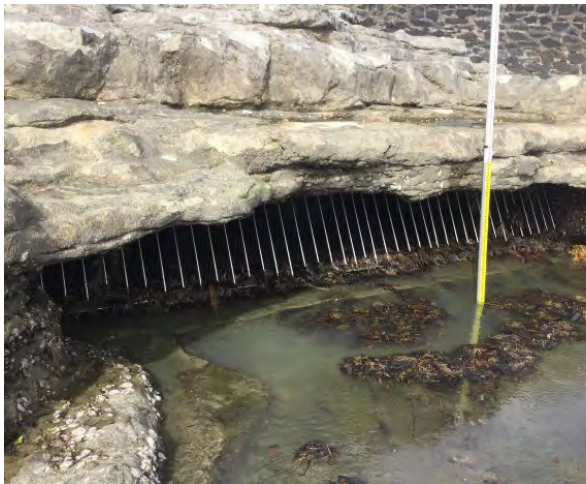
Auckland Council owned St Heliers coastal outlet with grill to trap debris is a partial barrier to swimmers and is likely to be temporal due to tides.

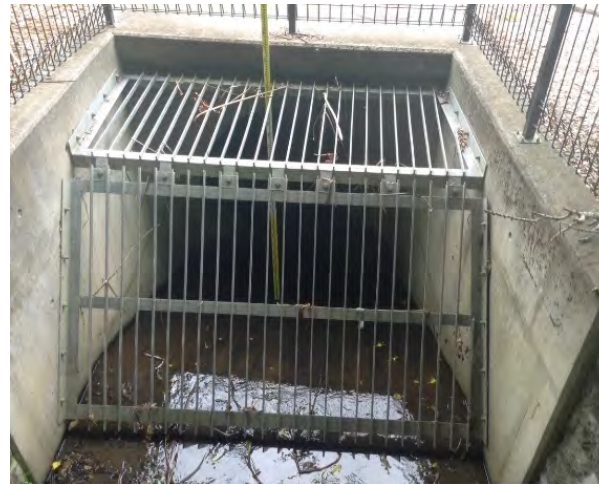
3. 7a Atkin Ave (2000082507, 2000258552) stormwater pipe dry at low tide and is affecting 1.28km of upstream habitat.
4. A culvert at the bottom of Dingle Dell reserve (2000919661) has a steep slope and a drop of 1m preventing swimmers but not climbers to access the 1.63km of habitat upstream.

Auckland Council owned inlet in Dingle Dell reserve (DIN_MAIN_2, 2000919661). A steep concrete ramp into the inlet was causing a barrier to swimmers.

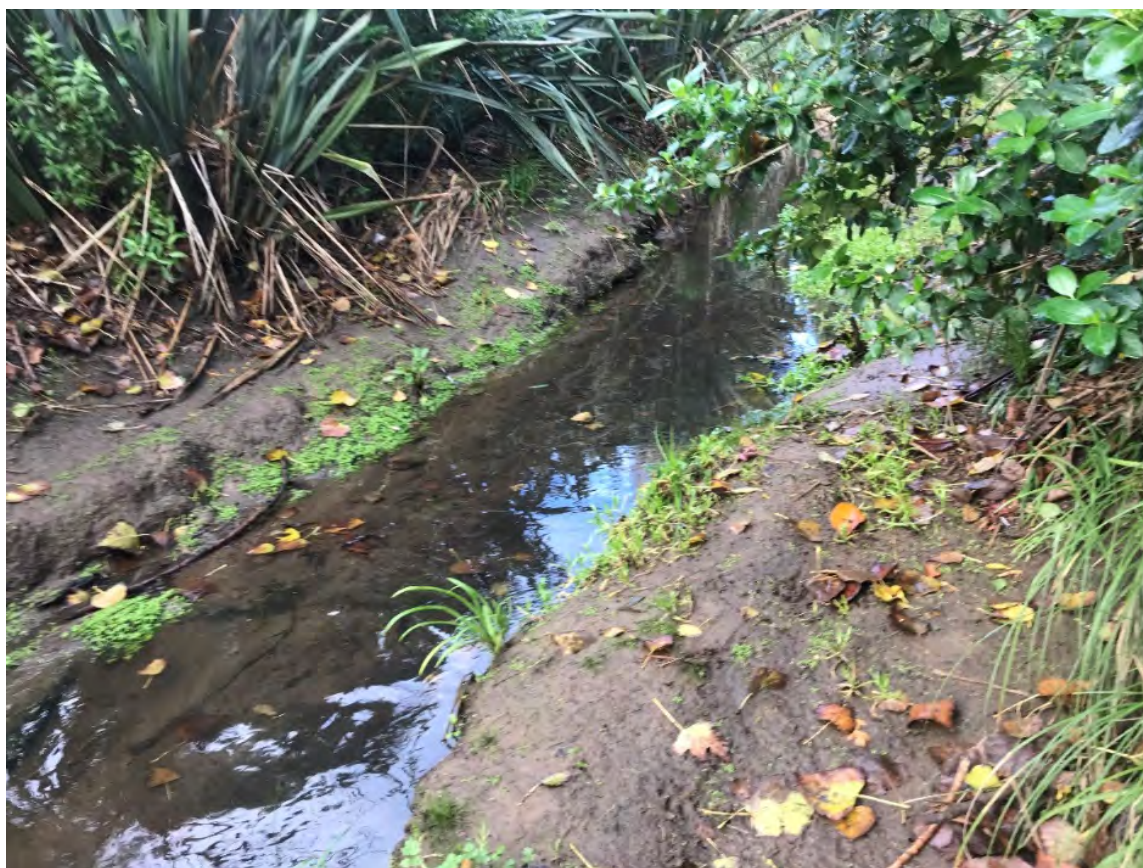
A reach (KOH_MAIN_11) in Madill's Farm Recreational Reserve has the potential to be suitable for inanga spawning if planted with suitable vegetation e.g. sedges (*Juncus* sp.) and oioi/jointed wire rush (*Apodasmia similis*) (see EO6). This area was identified as potential inanga spawning habitat due to wide low gradient floodplains with grass and flattened sedges that appear to be periodically inundated by tides (Figure 21).

Figure 21: Potential inanga spawning habitat with floodplain both banks that is periodically inundated by tides (KOH_MAIN_11).

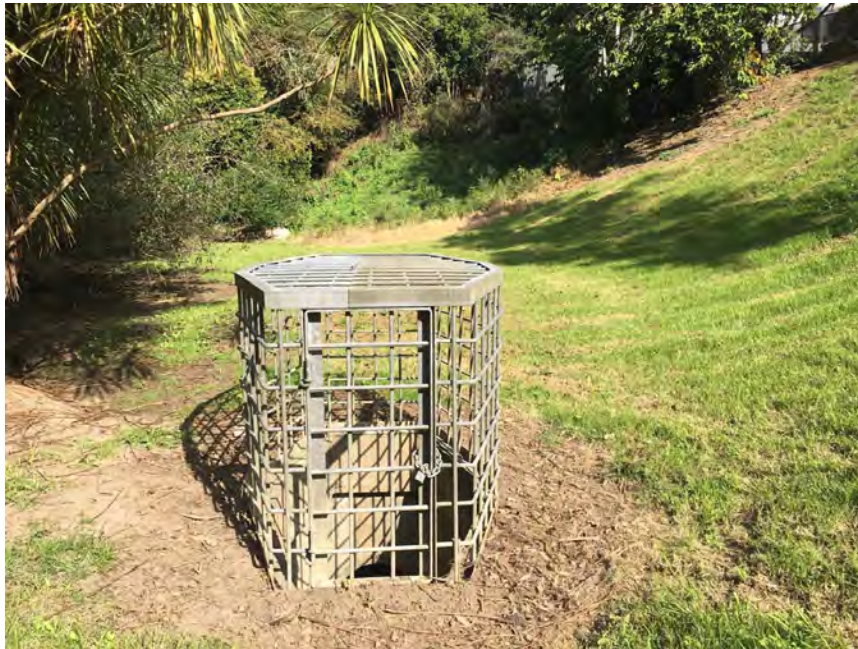
Figure 23: Dry Detention Pond located near (Tributary ID: KOH_TRIB6_1) constructed for stormwater management. The Council stormwater asset is located adjacent to private residential properties.

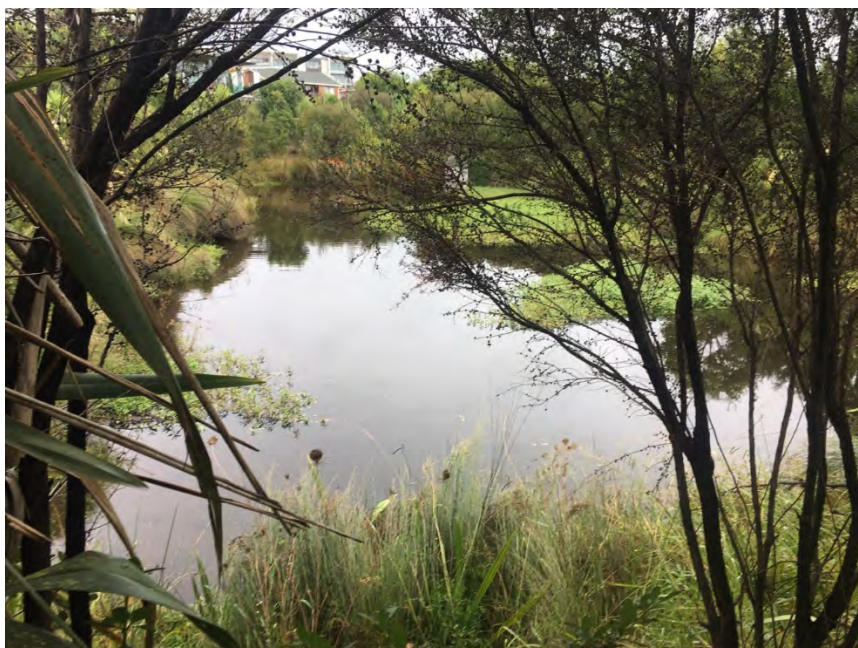
Figure 24: Wet stormwater detention pond, in the Glendowie catchment.

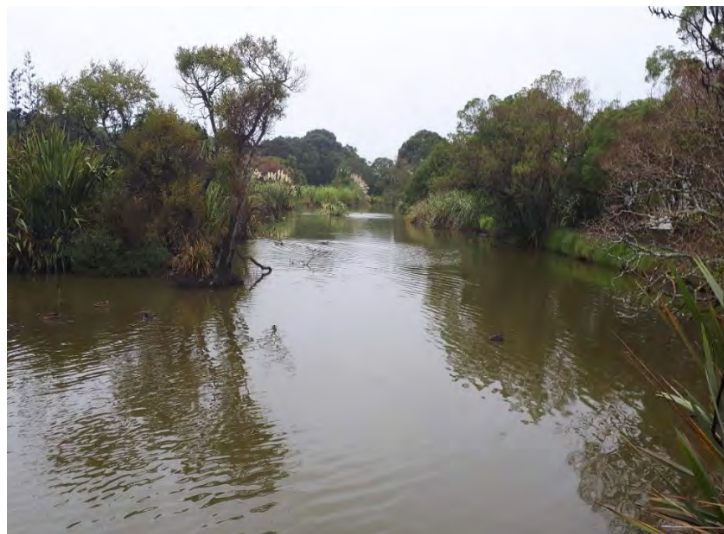
Figure 25: Natural coastal wetland in Tāhuna Tōrea Nature Reserve, dominated by native harakeke and manuka vegetation.

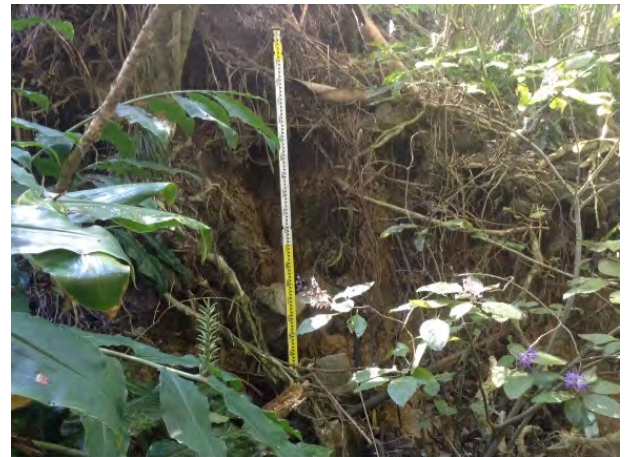
7. Severe erosion was occurring beneath the outlet point of the pipe at 92 Allum Street (2000565387) causing the dissipation structure to fall away. The structure had a greater than 1.5m drop. It was noted that although this asset might require replacement, it is not close to any structures nor is it posing any public risk.

The dissipation structure for the outlet at 92 Allum street (2000565387) has completely fallen away due to erosion.

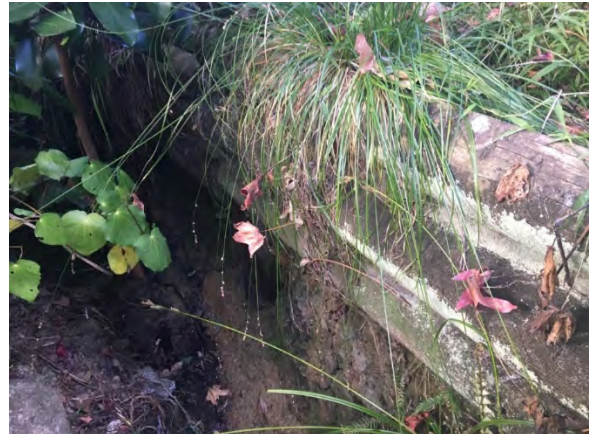
Bank lining at 18a Godden Crescent on private property (MIS_TRIB5a_1) (UNK_009).

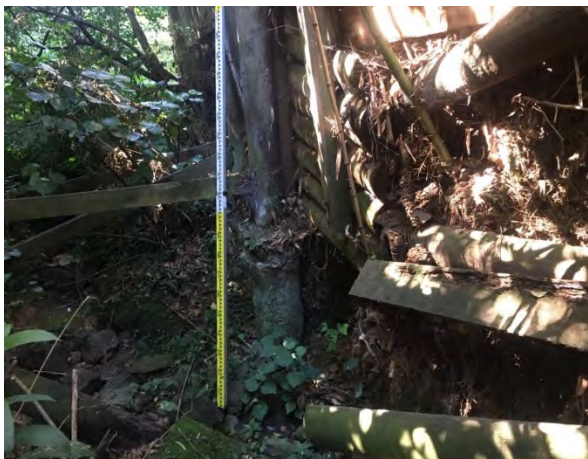
Bank lining undercut at 2/21 Geraldine Place (KOH_TRIB3a_5) (UNK_038).

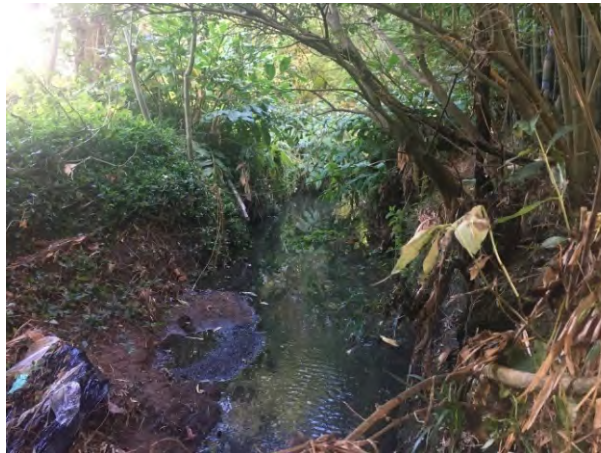
Glendowie Stream EBG02 (GLE_TRIB4_4)
Representative of residential reaches where weed infestations are common.

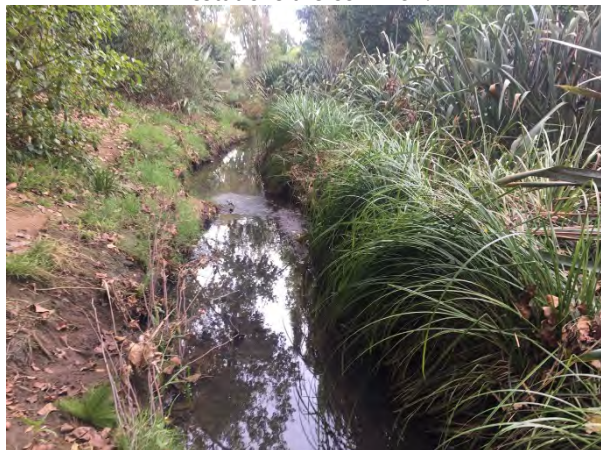
Kohimarama Stream EBG04 (KOH_MAIN_8)
Adjacent to Madill's Farm Recreational Reserve and sport fields.

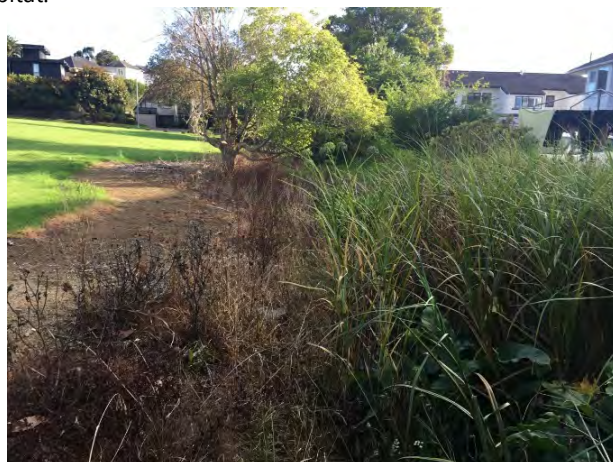
The Mission Bay Stream SEV site is representative of a public access stream with poor longitudinal extent of riparian cover and small to no banks. The SEV score of 0.370 indicates poor ecological condition as a result of very poor biodiversity and very poor habitat provision.

Mission Bay Stream EBG05 (MIS_MAIN_1)
Representative of streams with poor riparian vegetation and shallow banks.

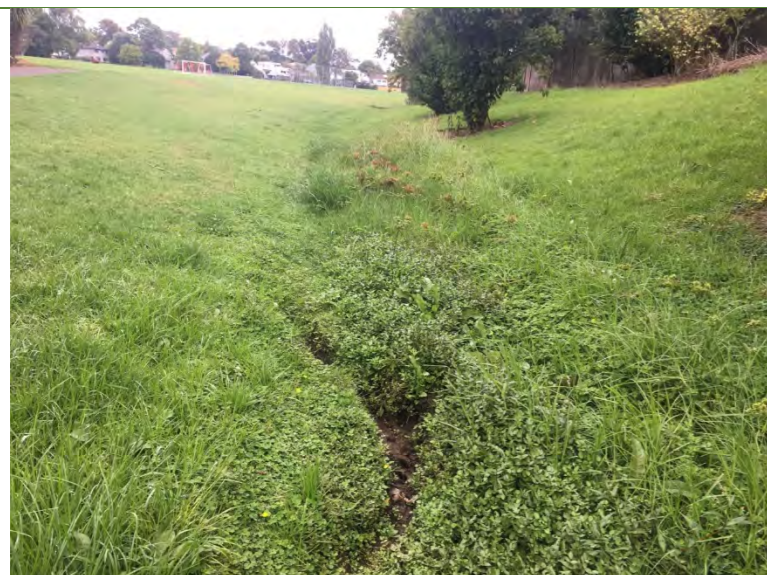
OLFP (Tributary ID: GLE_TRIB4_11) above the piped channel.

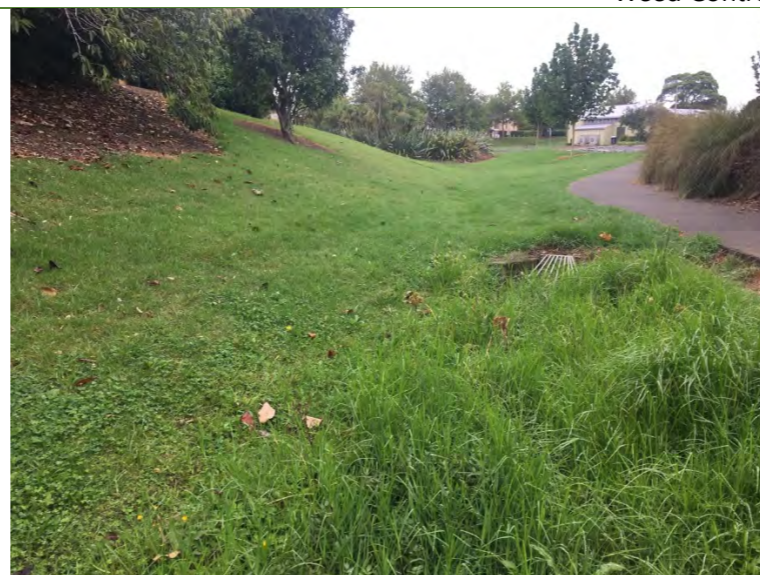
The concrete footpath on TLB of the proposed daylighting site.

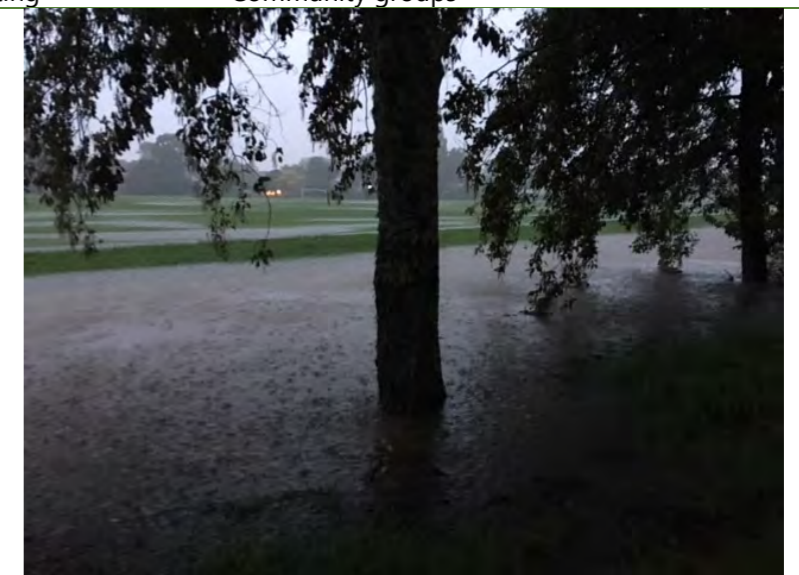
Flooding of field during heavy rainfall event in July 2018, from the TLB. Sent in by residents at 89 Esperance Road.

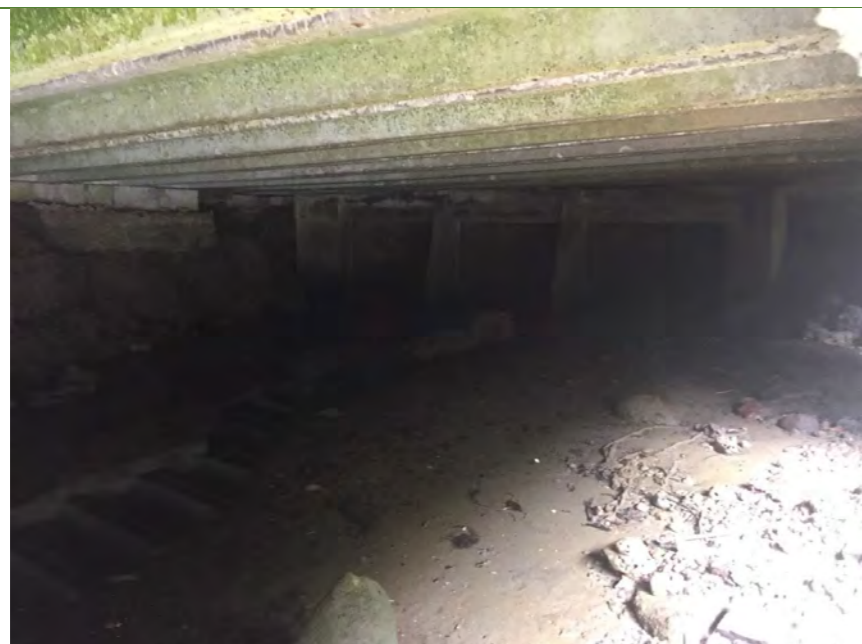
1. Three box culverts on the Atkin Ave are set back beneath the floor of a residential carport with parts of this floor spanning over the stream. It was deemed unsafe to enter this area to complete a full inspection of each individual outfall. The main column (cast in-situ) supporting the carport was identified to have a large crack that appears to be compromising its structural integrity with the potential to fail. The soil stream banks, beneath this spanned area, appear to be subject to active erosion caused by stormwater flows and bioturbation from the mud crab holes in the bank. The erosion extends 0.5-1.0m into the bank past the downstream rock wall channel lining (2000359099, 2000671763, 2000048193, see EO3 in section 6.0).

The 3 culverts (2000048193, 2000359099 and 2000671763) set back beneath parking garage.

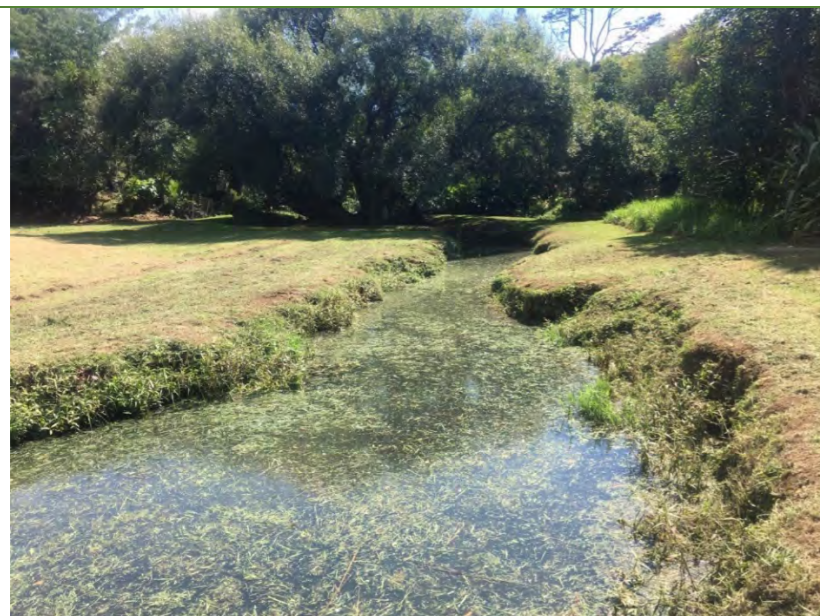
Open channel with dominated by lawn grasses providing limited filtering ability and no riparian shading (Trib ID: GLE_MAIN_3).

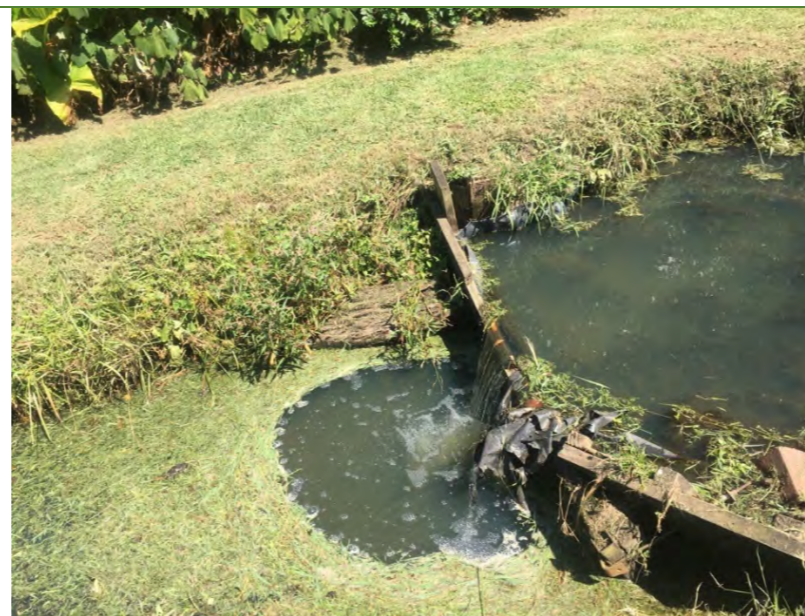
Multiple ad-hoc weirs and dams structures used to create ponding sections of stream.

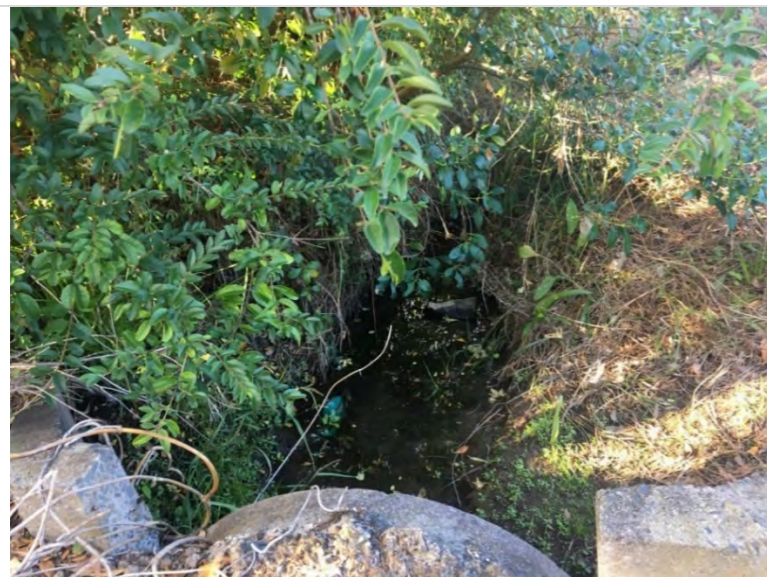
Outlet at the top of stream (SAP ID: 2000077826, 2000077826) showing low banks and poor vegetation.

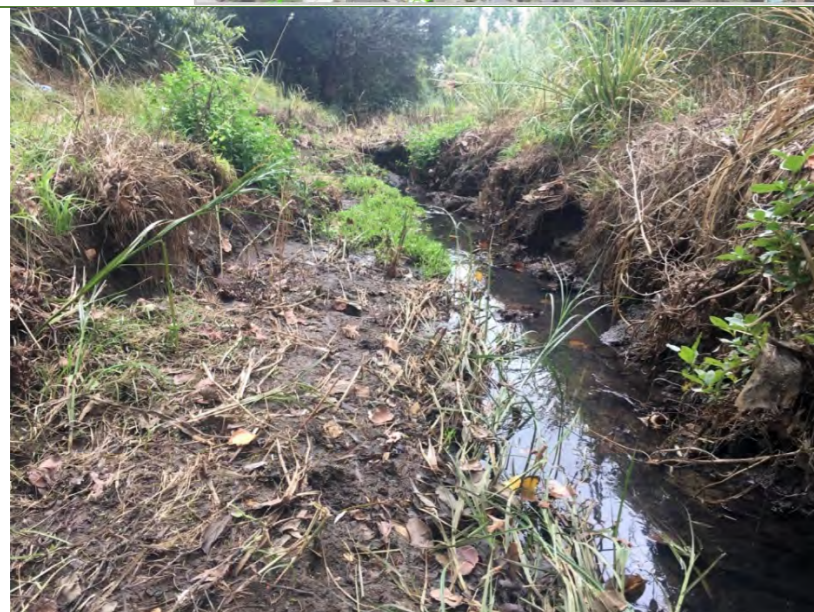
Mass wasting and slumping in the channel (Tributary ID: KOH_MAIN_10). Floodplain could be enhanced for inanga spawning habitat.

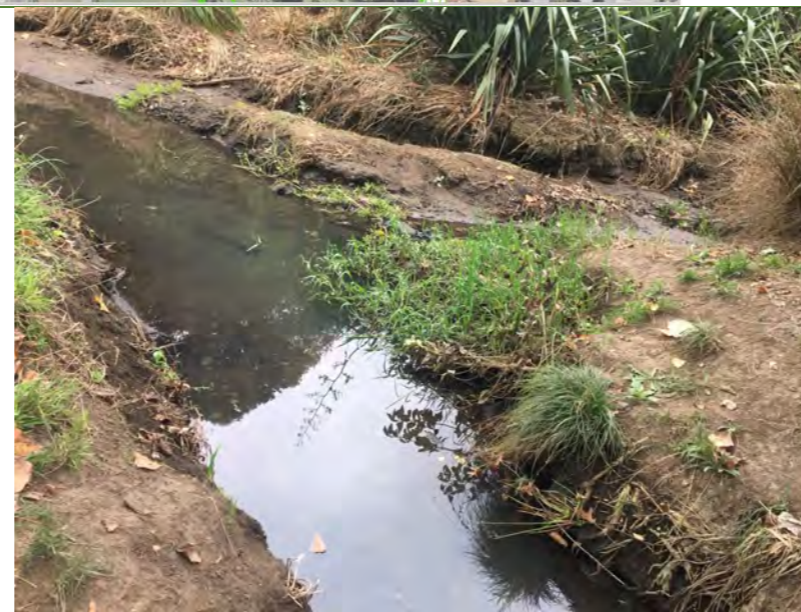
Erosion where the flows from the outlet (asset ID: 2000229311) hit the adjacent bank.

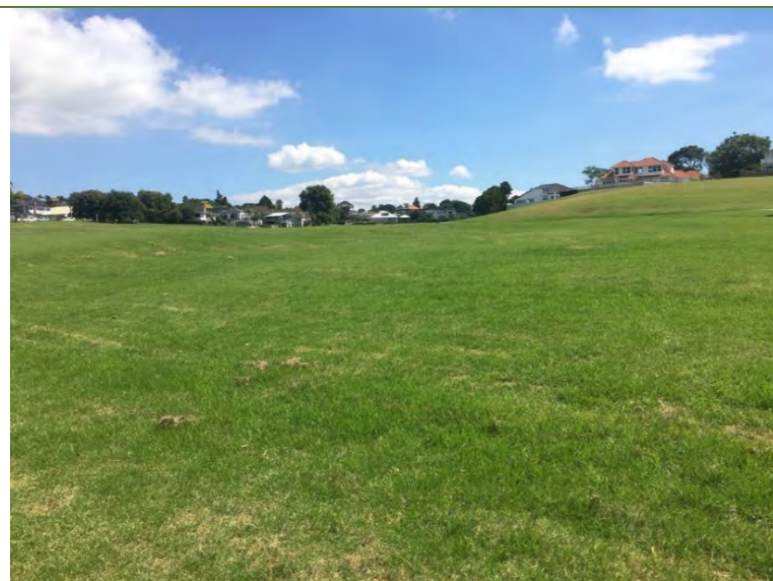
Glendowie Park with the piped channel underneath (GLE_MAIN_1).

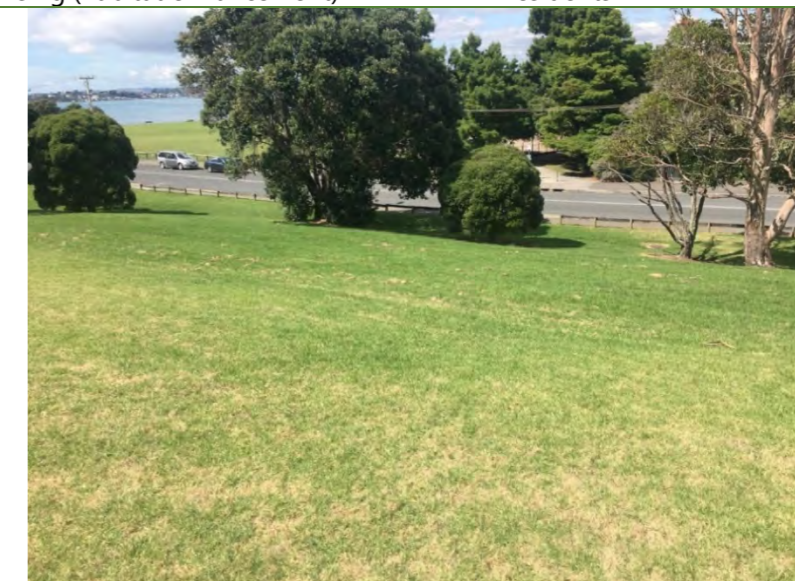
Glendowie Park with the piped channel, photo looking downstream.
