Eastern Bays and Glendowie Watercourse Assessment Report

Morphum Environmental Ltd, April 2020

Watercourse Assessment Report

Morphum Environmental Ltd.

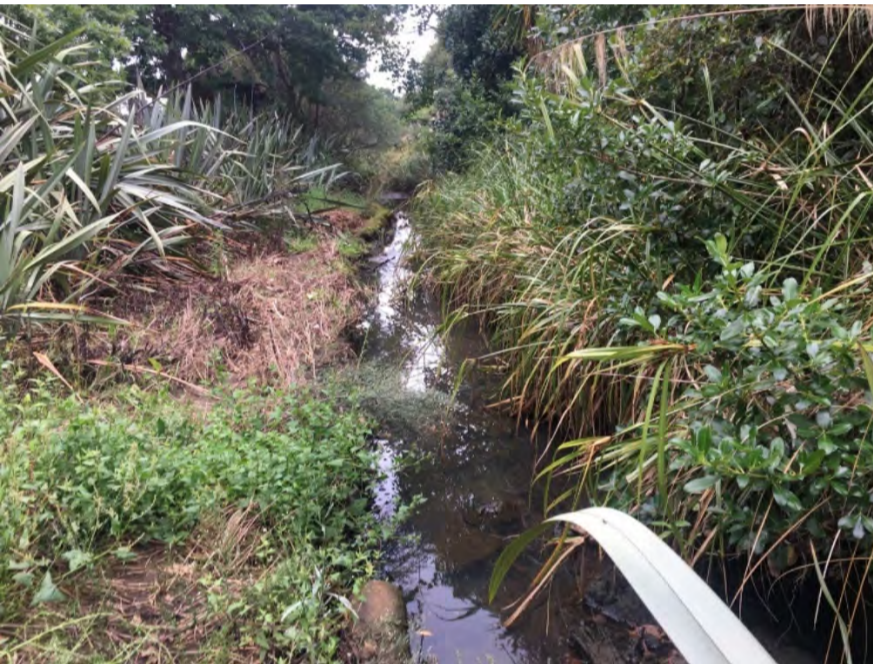
Kohimarama Stream that is straightened through Madill's Farm Reserve (KOH_MAIN_8).

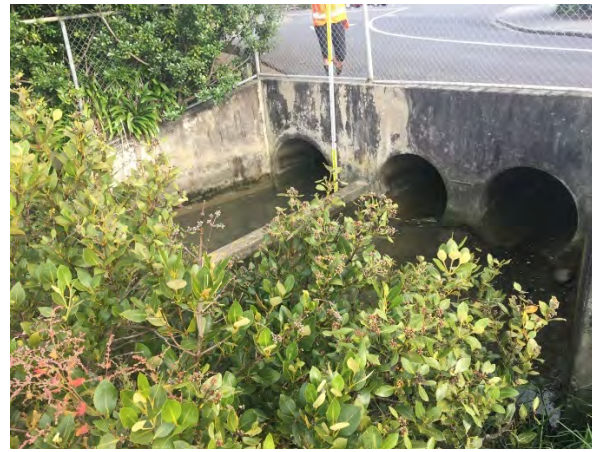
1. The Auckland Council owned coastal triple culvert on Glendowie Stream (GEE_MAIN_1, 2000621796, 2000816917 2000674479) which had a 0.04m drop from the apron to the coastal marine area/stream bed was affecting 550m of upstream habitat. This asset was assessed at low tide, so it is possible that it may be a temporary barrier that is tidally dependent (Figure 17).
2. An Auckland Council owned coastal outlet (2000473115) which discharges into the Glendowie Stream Mouth and coastal marine area has a 1m drop height across reno mattress into the channel bed. There is approximately 471m of open watercourse available upstream of this barrier however fish would have to swim up 118m of stormwater network (Figure 17).
3. A series of weirs present in Glendowie Stream (Tributary Code: GLE_MAIN_3) are causing complete barriers to a potential 760m of upstream habitat.

The Auckland Council owned coastal triple culvert on Glendowie Stream (GEE_MAIN_1, 2000621796, 2000816917 2000674479) which had a 0.04m drop from the apron to the channel bed.

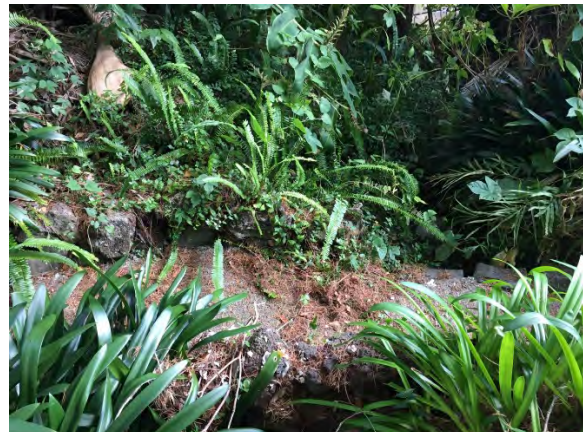
One miscellaneous point pose a potential risk for the flooding of habitable floors. A pedestrian bridge that crosses a tributary of Dingle Dell Stream, at the driveway of 35 Fern Glen Road had been completely blocked by debris and has the potential to flood habitable floors on 35 Fern Glen Road (DIN_TRIB4a_4) (Figure 34).

A pedestrian bridge that crosses a tributary of Dingle Dell Stream, at the driveway of 35 Fern Glen Road had been completely blocked by debris and has the potential to flood habitable floors on 35 Fern Glen Road (DIN_TRIB4a_4).

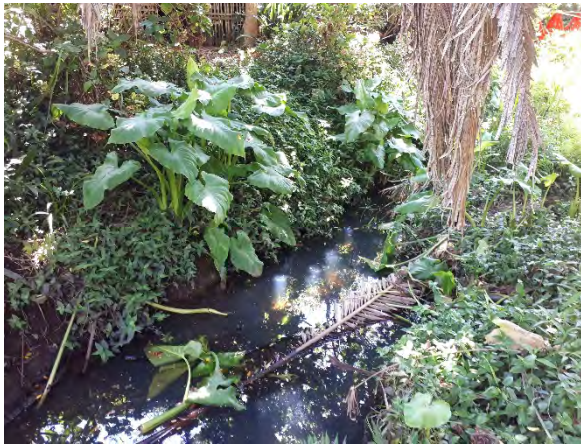
Glendowie Stream EBG01 (GLE_MAIN_9)
Regenerating riparian vegetation.

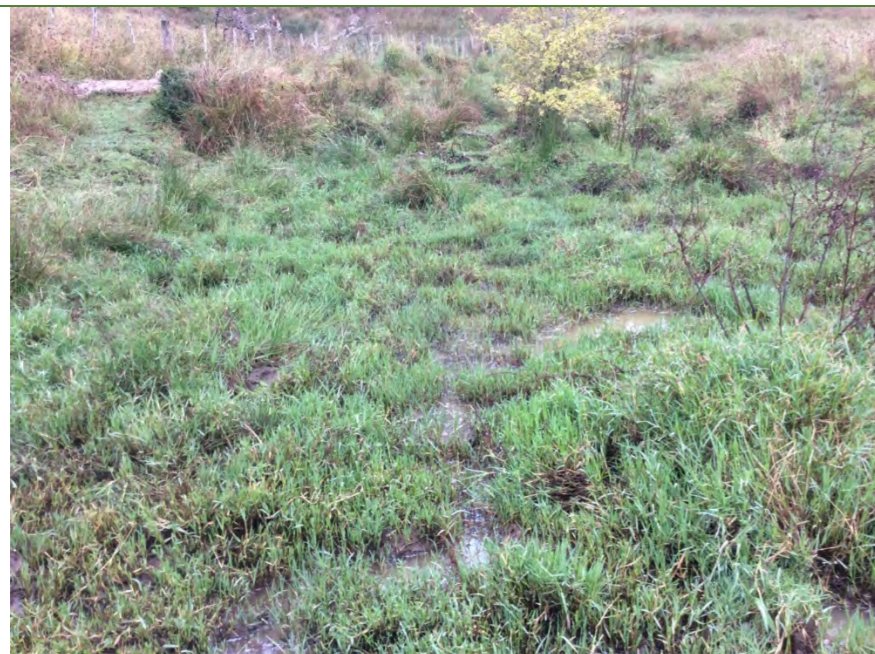
Modified channels with wetland-like characteristics (TRIB ID: GLE_TRIB6a_1).

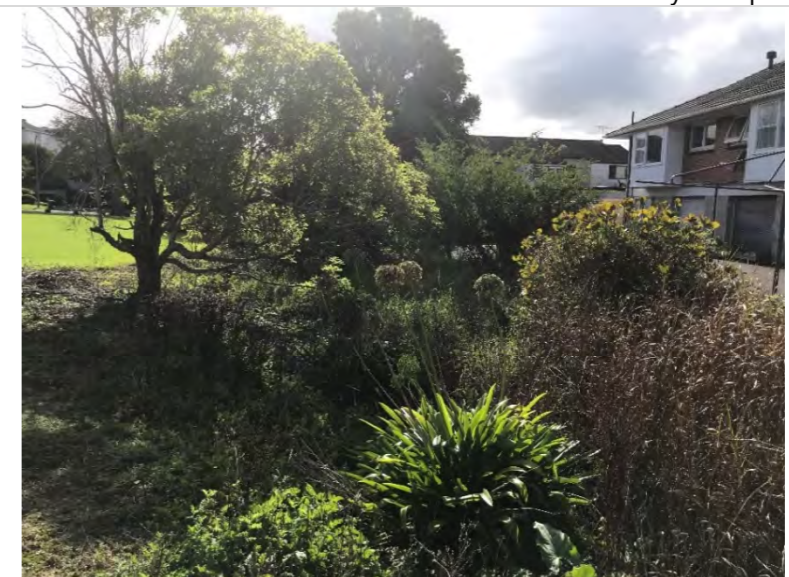
Narrow riparian longitudinal extent at MIS_MAIN_1.

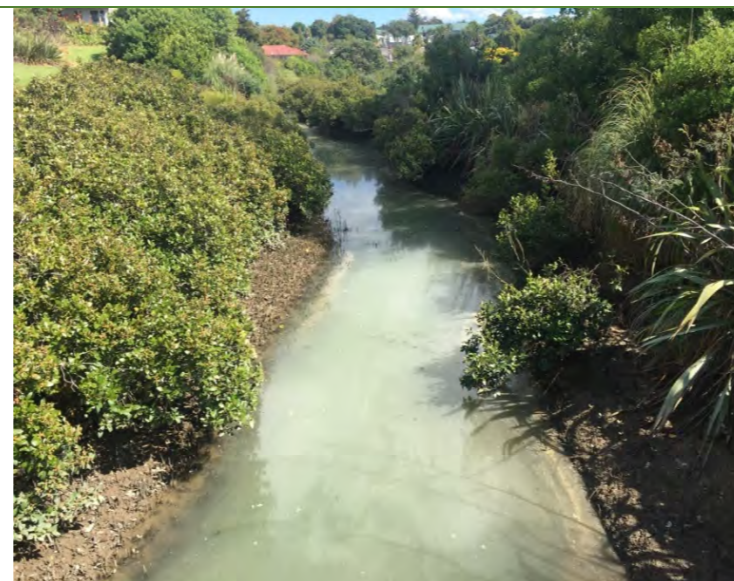
The stream mouth downstream of the piped reach.

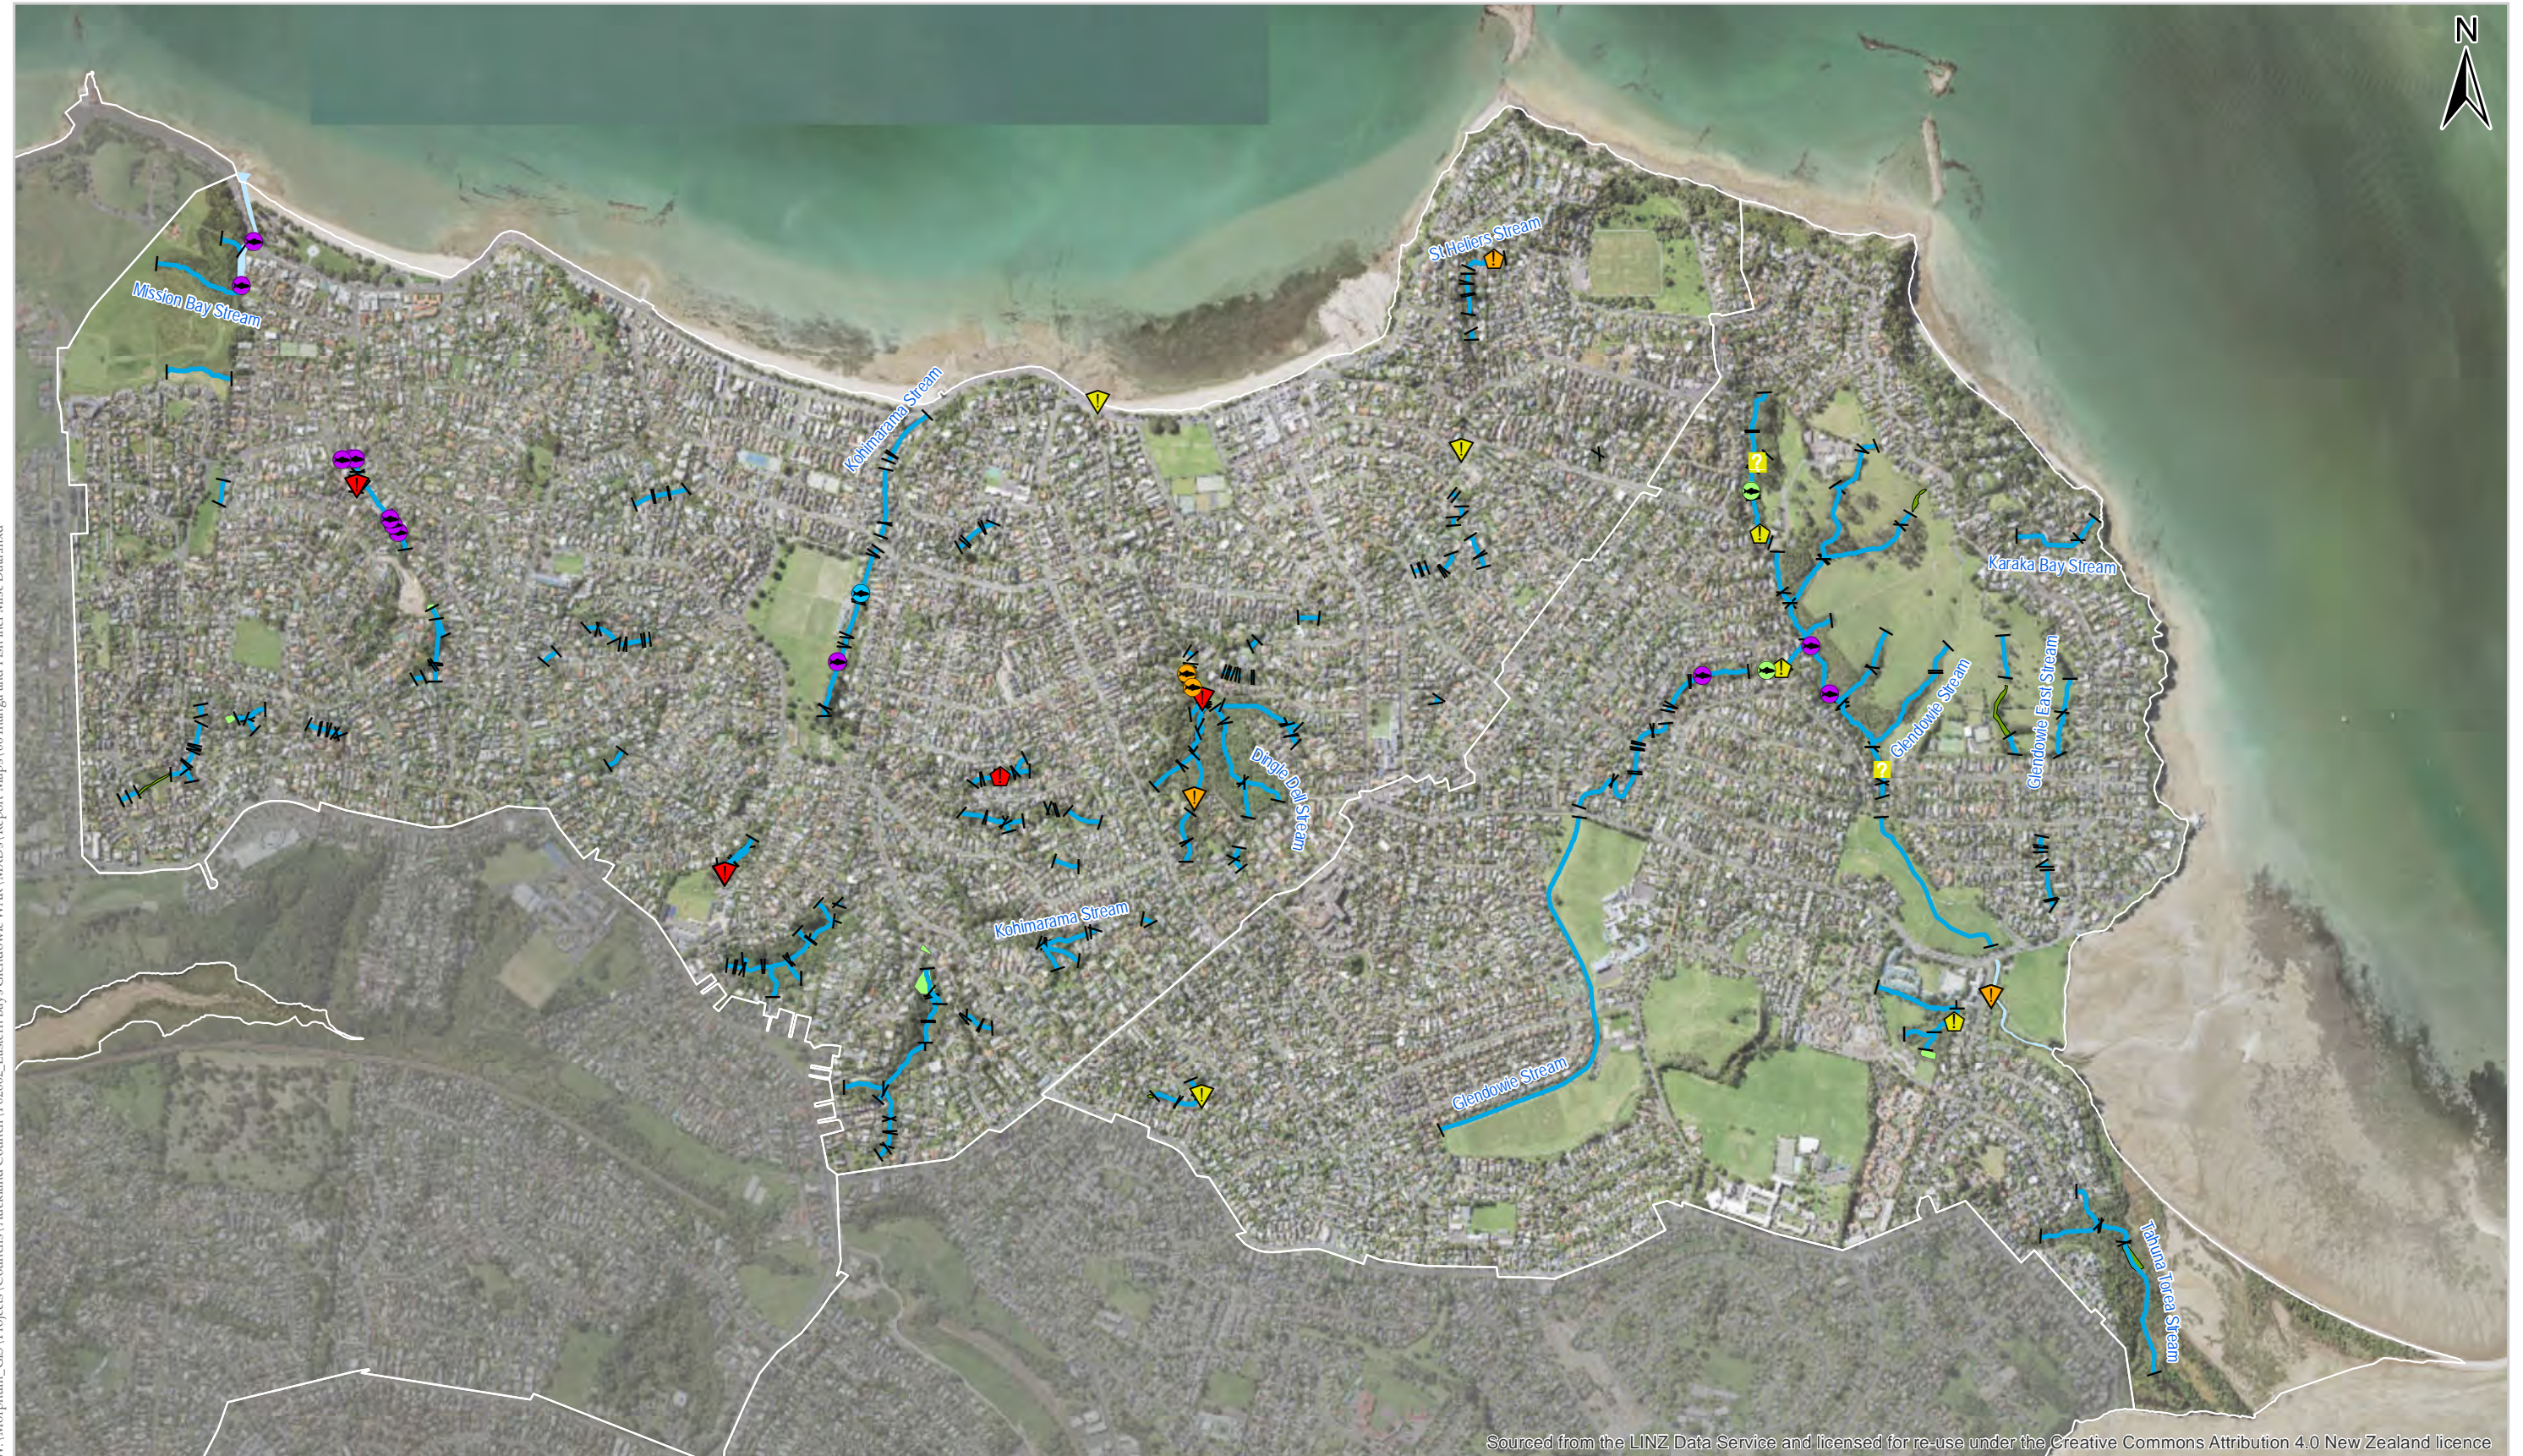
MAP 6 - INANGA AND FISH INCL. MISC DATA

A total of 10.66 km of open watercourse was affected by a fish passage barrier of some kind (complete, temporary or partial). A total of 104 structures were found to be some form of barrier to fish passage, with five of these being natural structures: cascades and waterfalls (Table 21). A total of 19 fish observations were recorded in the survey area. Most of these observations were shortfin eels, banded kokopu and unidentified bully. The two Auckland Council parks; Dingle Dell and Churchill Park have the most significant, intact regenerating native bush in the surveyed area. However, these reaches were also incised from fluvial processes, had erosion associated with stormwater outlets, noxious weeds, some stock access.

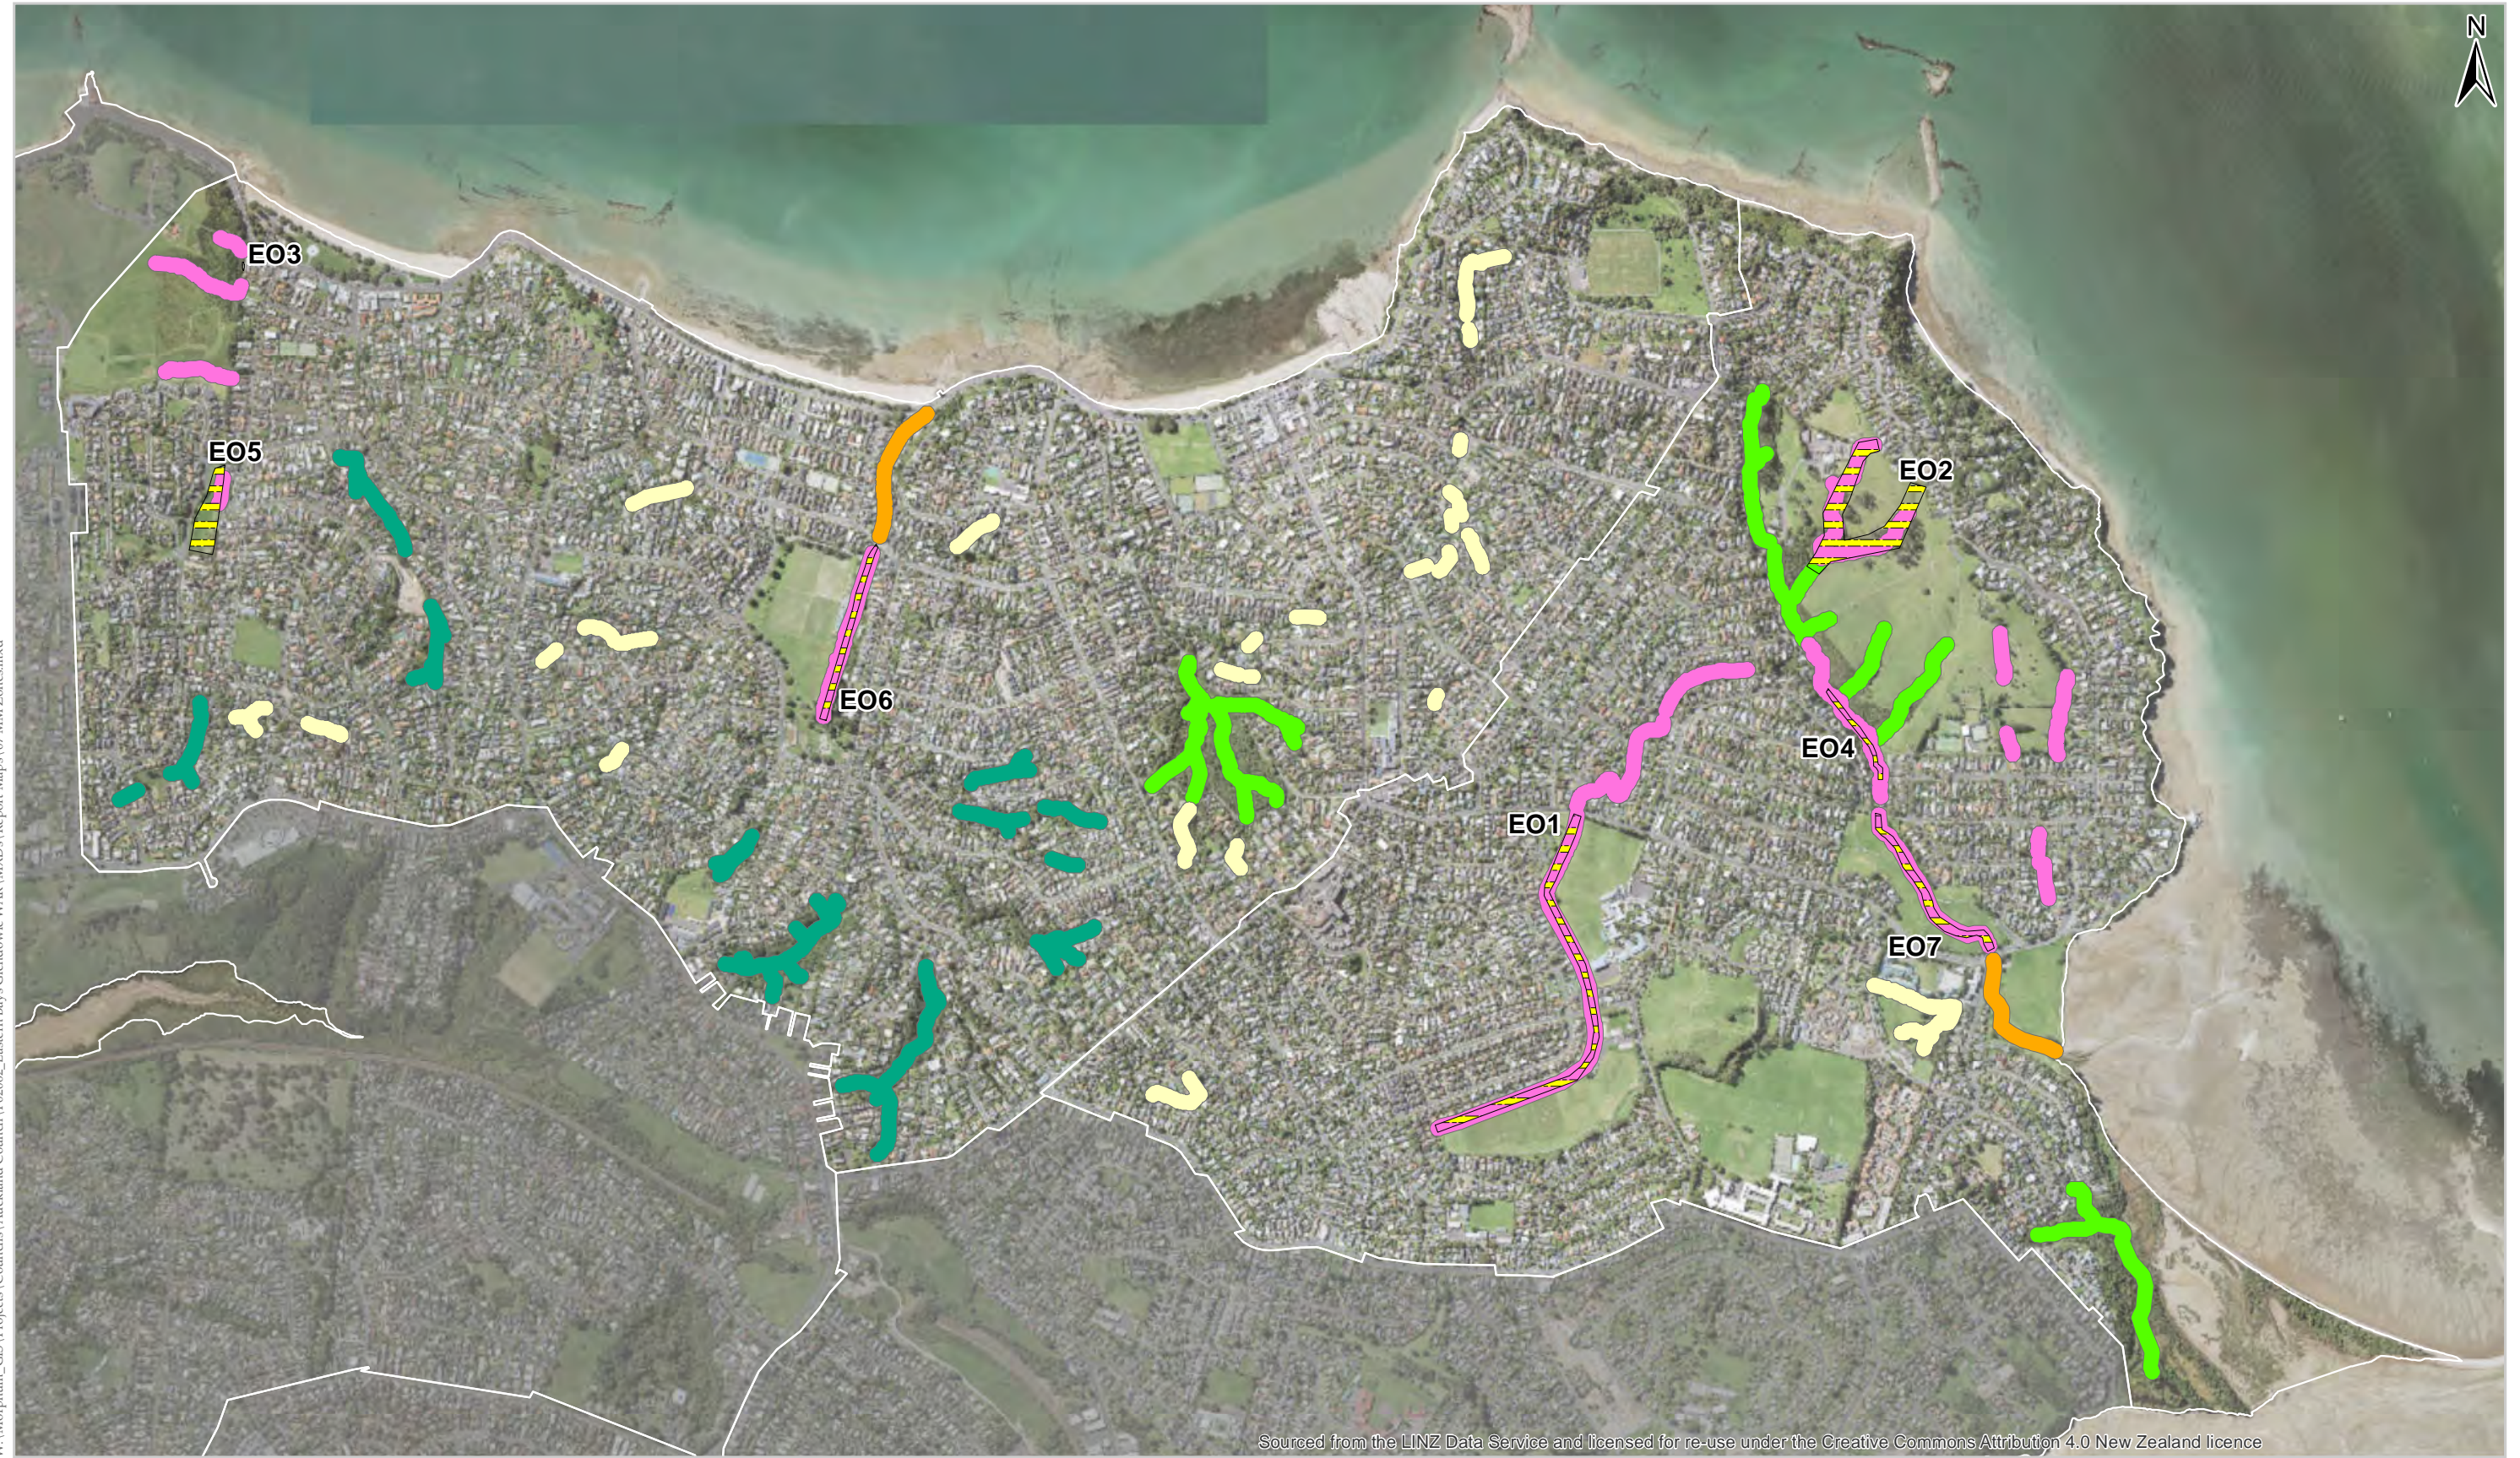
MAP 7 - MANAGEMENT ZONES

The findings of the field survey were used to categorise the watercourse reaches into five Management Zones. The Management Zones have overarching descriptions of reaches with similar pressures and issues. The purpose of categorising the reaches into management zones is to summarise key values, assessments and recommended actions at a high level to guide unified management across the wider catchment.
